# SAFETY ALERT

## Servo Tab Spring

### SA-ASTM-CTSW-02

### Servo Tab Spring

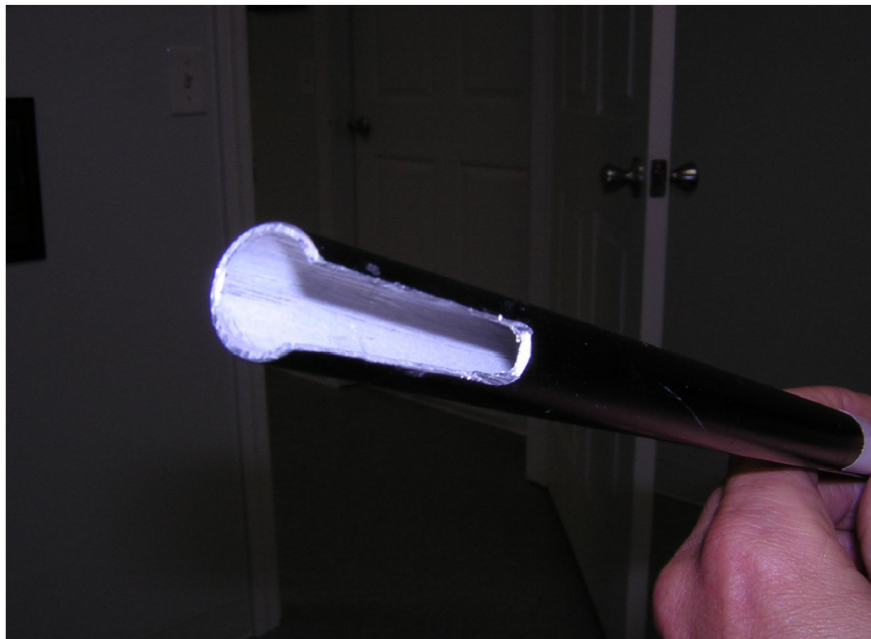
Fig. A

Note: The U.S. distributor has found that a tool as shown in the Modification document, with an additional slot to allow for the Ball-joint (Fig.A), works well for disassembly and that safety wire works best for holding the spring compressed during assembly.

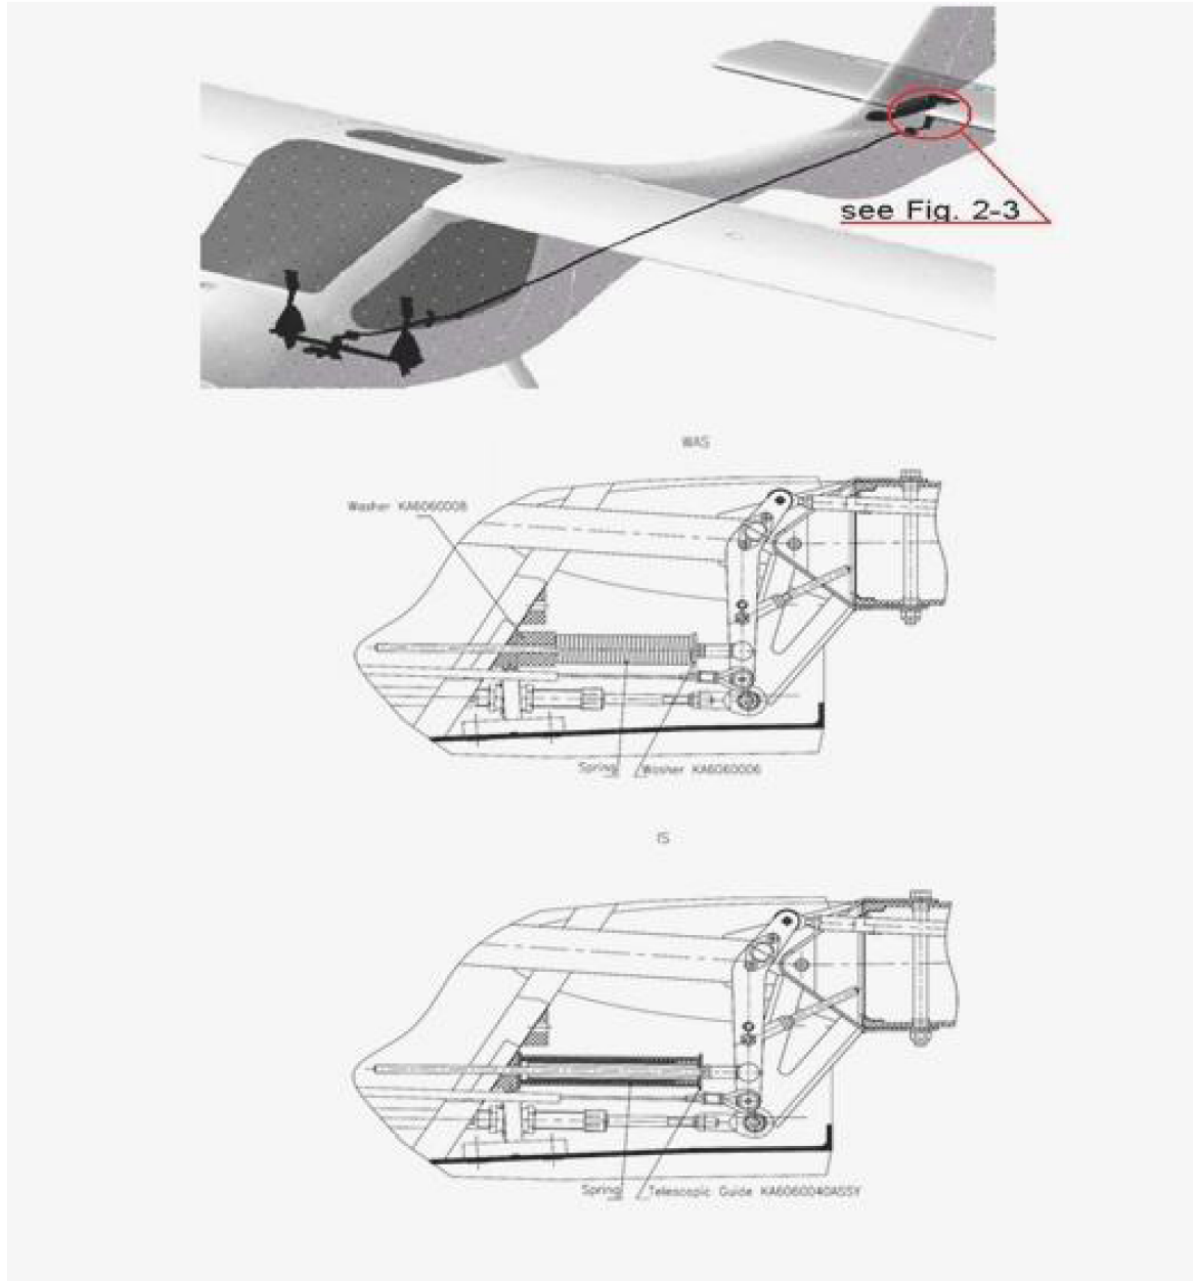
It was found that the anti-servo tab spring could, under extreme conditions, cause a sudden change in trim force pressure. This could result in a pitching down movement of the aircraft that is most pronounced as Vne is reached or exceeded.

Fig. B Location of the Servo Tab Spring as illustrated in the Modification document.

Flight Design is mandating a modification of the trim system on the affected aircraft that consists of replacing the original spring and associated spacer and washer with a new spring and telescopic spring guide assembly.
