SAFETY ALERT

Trim Tab Reinforcement

SA-SECS-CTSW-03

Technical Advice No.13 – revision 2

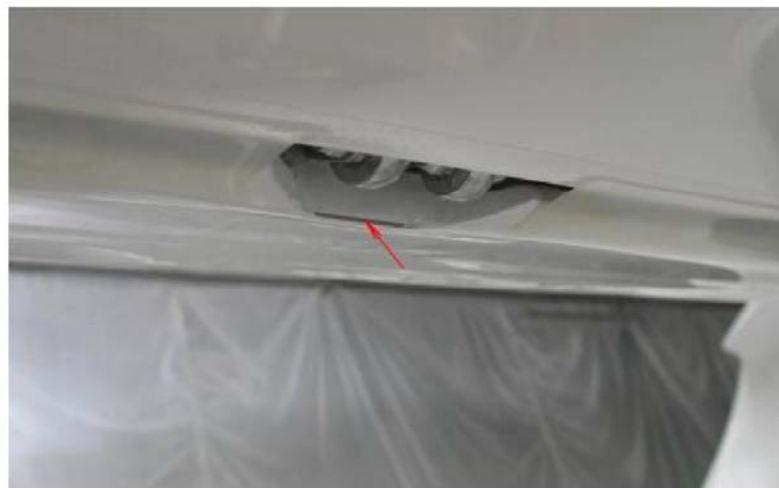
Fig. A: Inspection area: Trim tab control horn attachment point
 (Seen from underneath the stabilator)

The investigation did determine that a pitch control vibration could result from the upper and lower trim tab (anti servo tab) skin exactly in the area of the Trim Tab Bracket (Part No. KA 3011110) as evidenced by a crack located at the attachment point. (Fig. A)

Flight Design is mandating an immediate inspection of the Trim Tab Bracket attachment area, with special consideration of the trim tab composite structure. The inspection will be performed before the next flight and thereafter prior to the first flight of the day. When performing the inspection, the trim tab has to be carefully loaded by hand in the center area, in order to expose potential damage.

If cracks are found in the area of bonding (attach point) (Fig. A), the aircraft must not be flown until the mandated reinforcement procedure is completed.

Regardless whether cracks are found, all aircraft listed in this Safety Directive are subject to the modification procedure within the next 25 flight hours, or at the next maintenance interval, whichever occurs first.

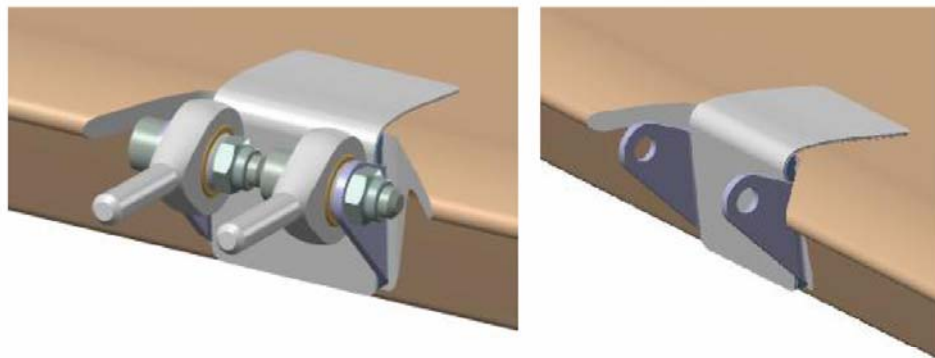
Fig B1 & B2: Reinforcement installed to the trim tab
(Tab shown bottom surface facing up)

The reinforcement procedure consists of reinforcing the point at which the control horn is bonded to the trim tab by the addition of specifically designed part manufactured by Flight Design (WA 3011011). The part is glued (bonded) to the control rod bracket and the lower trim tab surface and delivers a secondary load path for the trim tab control forces. The modification can be done without removing the trim tab, and does not require painting action. (Figs.B1 & B2)

The procedure shall be completed according to Flight Design document: "070625 – TRIM TAB REINFORCEMENT PROCEDURE" that accompanies this Safety Directive, and supplemented by the Maintenance Manual.
