SERVICE BULLETIN

Garmin SL30 and SL40

Comm Radio Spurious Emissions Correction

SB-LTUL-CT__-04

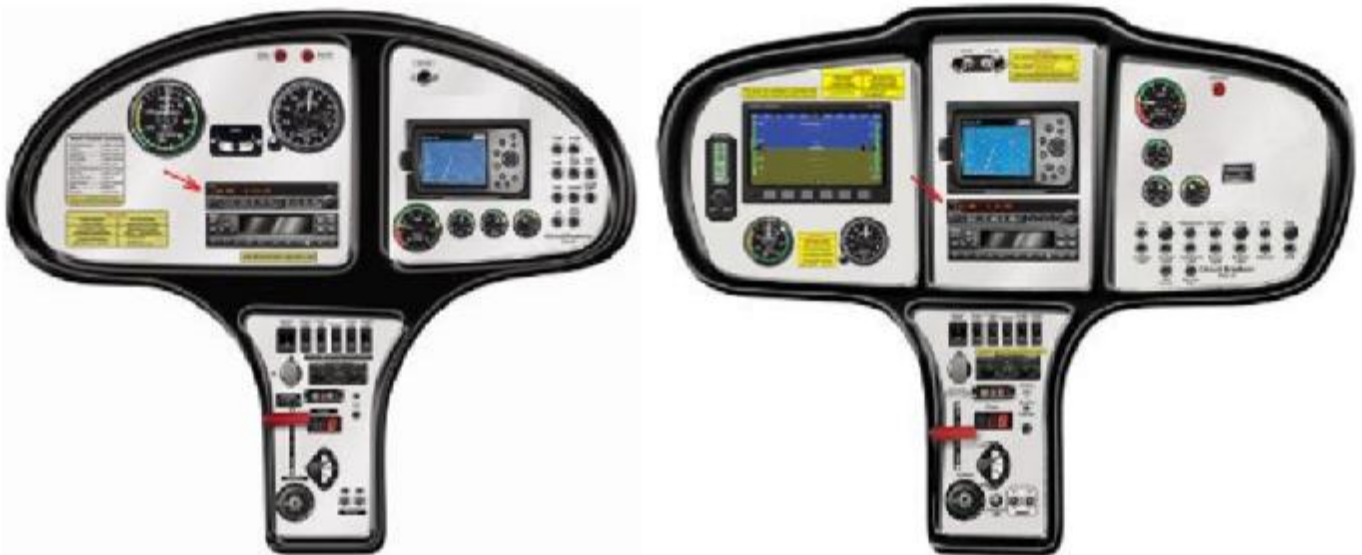
Fig. 1

Typical installation locations of the units are shown in Fig. 1.

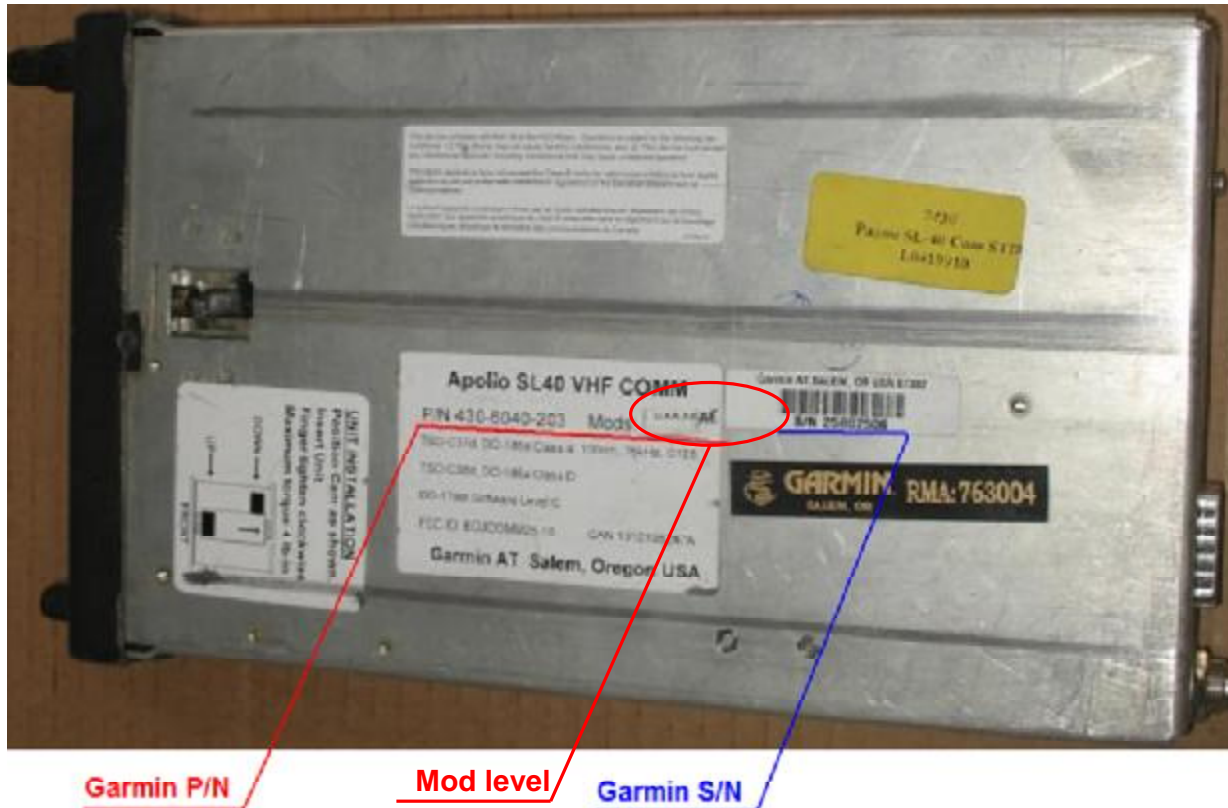
Fig. 3

Identify the Mod level from the nameplate on the bottom side of the unit. P/N, Mod level and S/N of the individual unit are shown in Fig. 3.
