## Landing Gear Inspection

SB-SECS-CT\_\_-01;  
 SB-SECS-CT2k-02;  
 SB-SECS-CTSW-02

Technical Advice (Service Bulletin) No.10-TM4

CT, CT2K and CTSW all versions

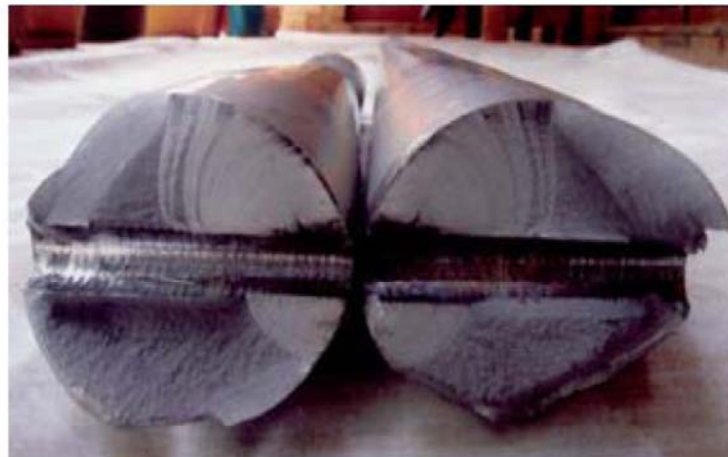
A main landing gear leg breakage was reported on 7<sup>th</sup> November 2005. Our local representative has not yet obtained the broken leg for analysis. According to pictures the gear leg may have been damaged before breakage. To date, there have been no known cases of leg breakage on undamaged main gear (bent or cracked). In some cases where planes have been flown with damaged main landing gear, failure has occurred.

All landing gear legs must be inspected every 300 hours or annually whatever comes, first using magnified visual inspection or a dye penetration test. A similar inspection must be made after a hard landing. Note: Bent landing gear or landing gear with cracks must be replaced before next flight.
