Service Bulletin	
	Flight Design GmbH Sielminger Str. 51 D-70771 L.-Echterdingen Tel.: +49(0)7021 80460-0 Fax: +49(0)7021 80460-69 E-Mail: airworthiness@flightdesign.com	SB-ASTM-CTSW-10 Revision 01
	Date of Initial Publication: 19-Jul-2012 Publication Date of this Revision: 30-Jul-2012

Inspection of the Rescue System Rear Harness Connection SB-ASTM-CTSW-10

Type: CT
 Model: CTSW LSA
 Serial Number: from 06-01-07(included) to 06-11-13(included); only those with installed BRS1350 HS Airframe Emergency Parachute System
 Applicable Countries: USA

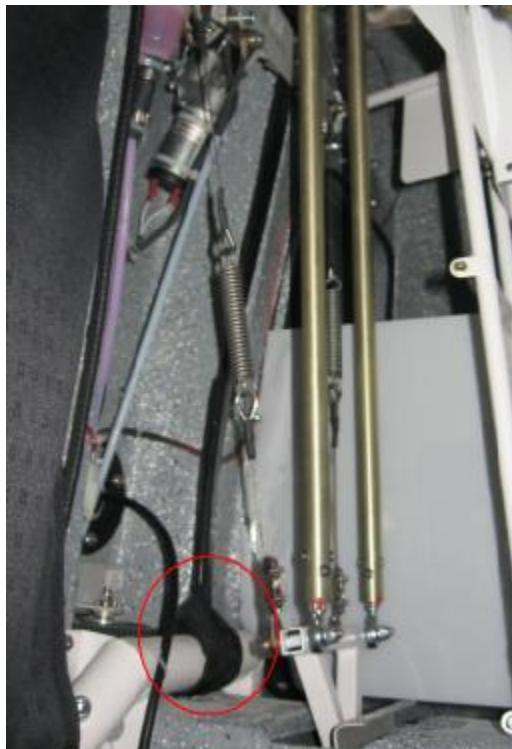
Fig. 1

- Rear harness is present and attached at the lower end to the landing gear bracket, on top of the tunnel inside the luggage compartment area. See [1] chapters 3.1- 3.2, or Fig.1 in this document, below (variants of both documents are acceptable and provide interchangeable results).

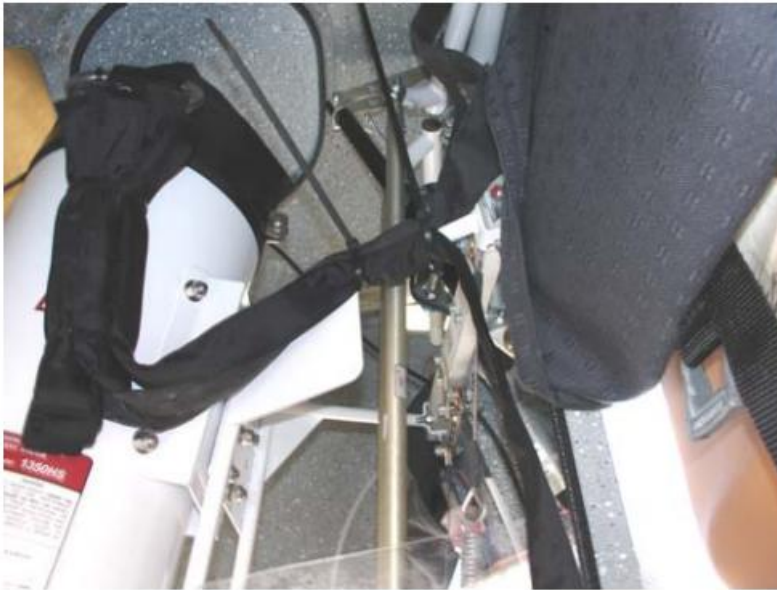
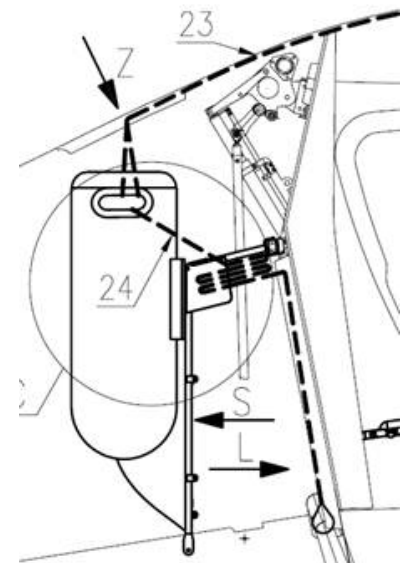
Fig. 2

- The harness is routed upwards along the rear side of the main bulkhead, along the right side (in direction of flight) support tube of the parachute bracket towards the parachute canister, where it is connected together with the front harness belts to the quick link that is stowed at the right upper side of the parachute canister – see Fig. 2.

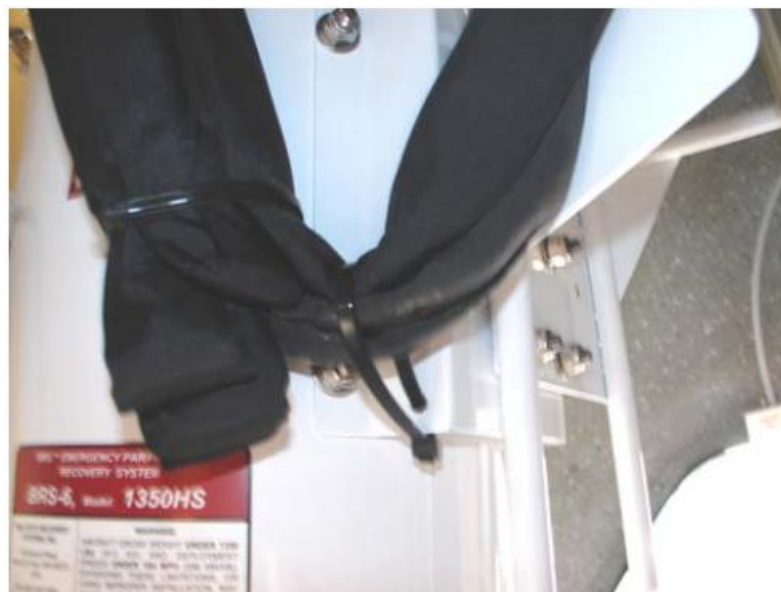
Fig. 3

- The routing is such that it does not get blocked by any structural component or control system element when extracted. The complete rear harness is properly affixed in position using cable ties so that it cannot entangle with any part of the aircraft controls – see Fig. 3.
