Safety Alert	
	Flight Design GmbH Zum Tower 4, D-01917 Kamenz Tel.: +49 (0)3578 37335 0 Fax: +49 (0)3578 37335 69 airworthiness@flightdesign.com	SA-ASTM-CTLS-04 Revision 00
	Date of Initial Publication: 19-Dec-2013 Publication Date of this Revision: 19-Dec-2013

CTLSi Rotax Redundancy Diagnosis SA-ASTM-CTLS-04

Diagnosis of the Regulator board A and B connection on the engine Rotax 912iS.

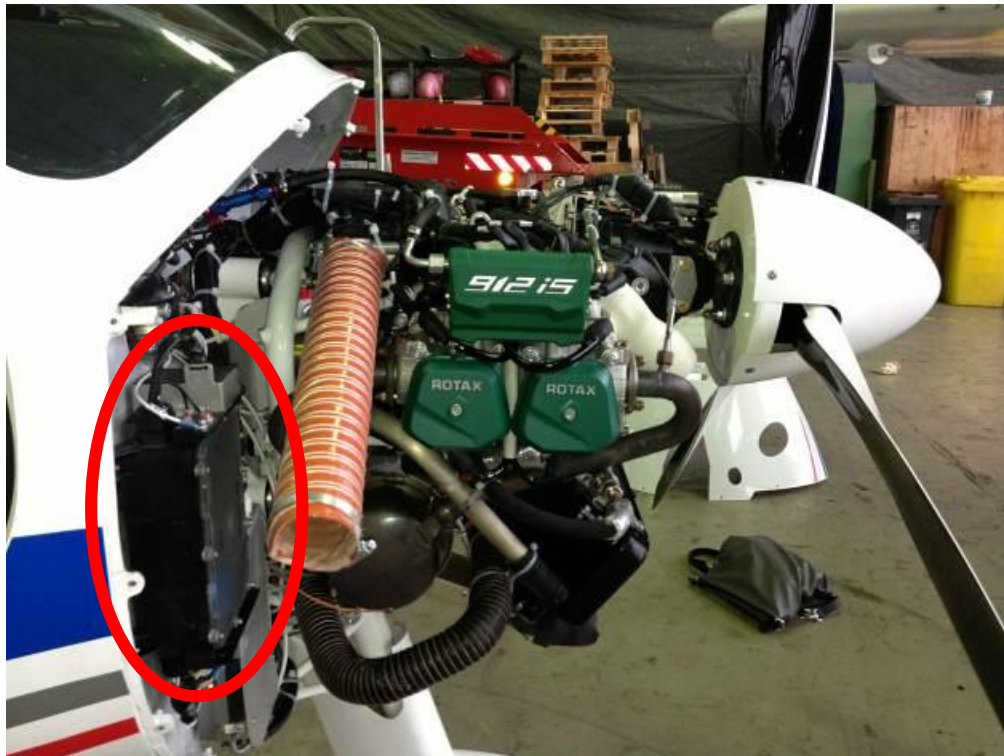
Fig.1

Identify the fuse box on the right side of the firewall (in flight direction). See Fig.1.

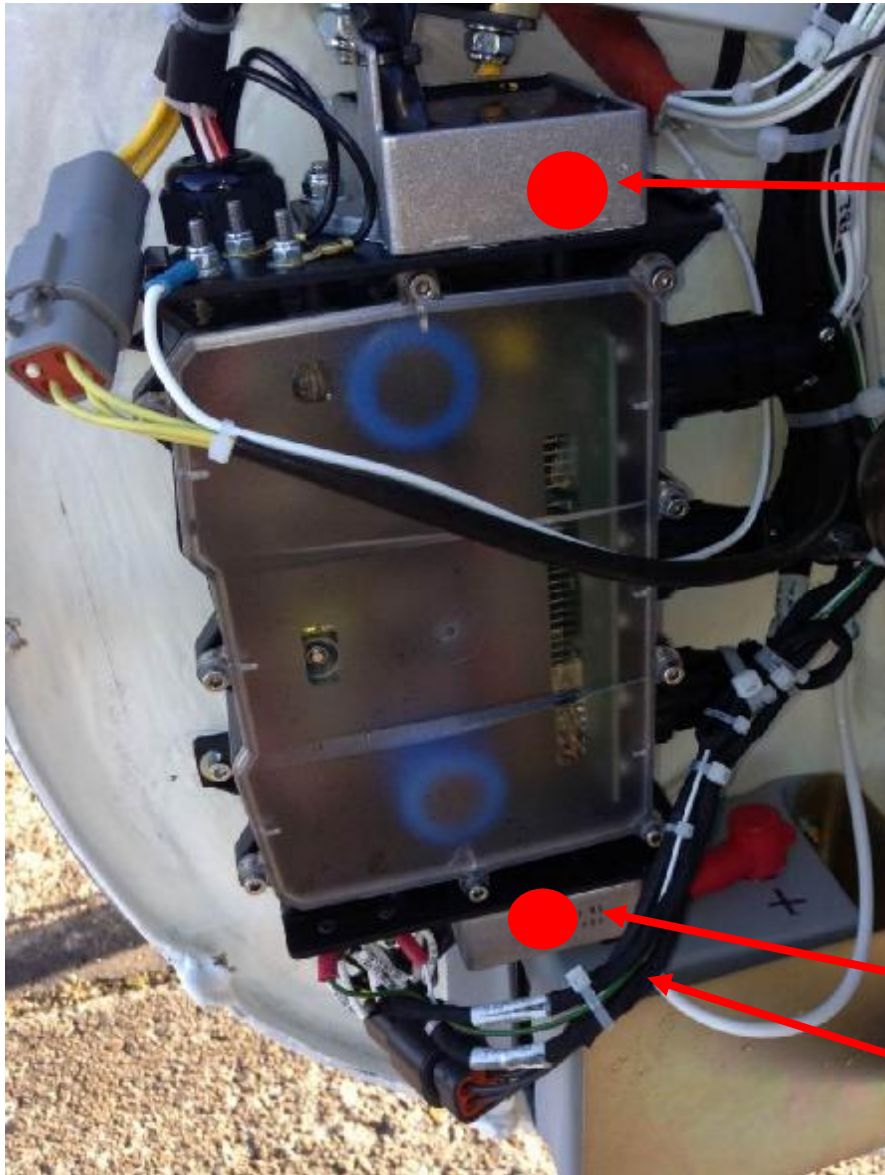
Fig.2

Use a Multimeter to verify electrical ground connection between the regulator Board A and B (red marked points on the Fig.2).

Regulator Board B
electrical Ground

Regulator Board A
electrical Ground

Regulator Board A
Ground Wires

There **must not** be an electrical connection between Regulator Board A electrical ground and Regulator Board B electrical ground.

▲ Warning: Do not operate the aircraft if there is an electrical ground connection between Regulator Board A and B.

If there is ground contact, the reason may be that the Lane A harness ground wires are wrongly connected with Lane B regulator board (upper regulator, above the fuse box). In this case, remove the Lane A wiring harness end (also marked with a label as "Lane A") from the Lane B regulator board. Connect this wiring harness end to the Lane A regulator board, which is the one below the fuse box. Fig. 2 shows the correct step. Re-do the test with the multimeter as above. The aircraft may be operated again, when there is no more ground contact between the two regulator boards. If the problem persists, please contact Flight Design for further instruction.
