Service Bulletin	
	Flight Design GmbH Zum Tower 4 01917 Kamenz Germany Tel.: +49 (0)3578 37335 0 Fax: +49 (0)3578 37335 69 E-Mail: airworthiness@flightdesign.com	SB-ASTM-CTLS-12 Revision 01
	Date of Initial Publication: 18-Nov-2015 Publication Date of this Revision: 02-Dec-2015

in the level of a Service Directive
USA Data Plate Replacement
SB-ASTM-CTLS-12

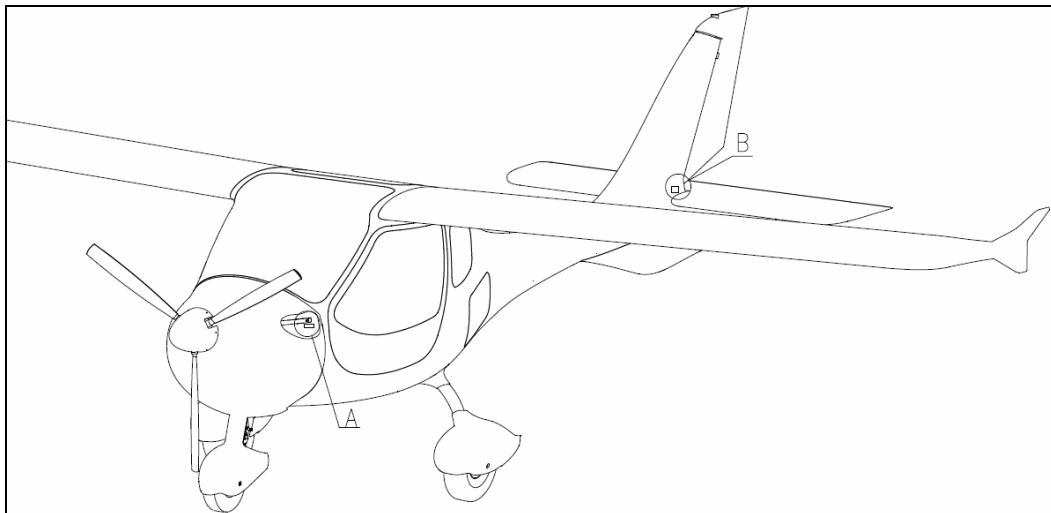
Fig. 1 – Location B data plate is affected

Aircraft registered with the FAA are required to comply with all recognized ASTM International industry standards. One update of the standards issued in 2012 was adding a requirement to show the country of manufacture also on the stainless steel data plate of the aircraft. The aircraft listed above have been delivered with data plates that do not show the country of origin.

- **Caution:** This instruction only affects the data plate attached to the left hand side of the tail boom of your aircraft (location B in Fig. 1). The data plate installed to the firewall is not affected.

The rear data plate attached to the left side of the aircraft tail is replaced with an updated data plate that shows the country of origin. The exchange is done in a controlled way, to ensure proper replacement, receipt and disposal of the removed data plates.
