SERVICE BULLETIN

Garmin SL30 and SL40

Comm Radio Spurious Emissions Correction

SB-ASTM-CT__-03

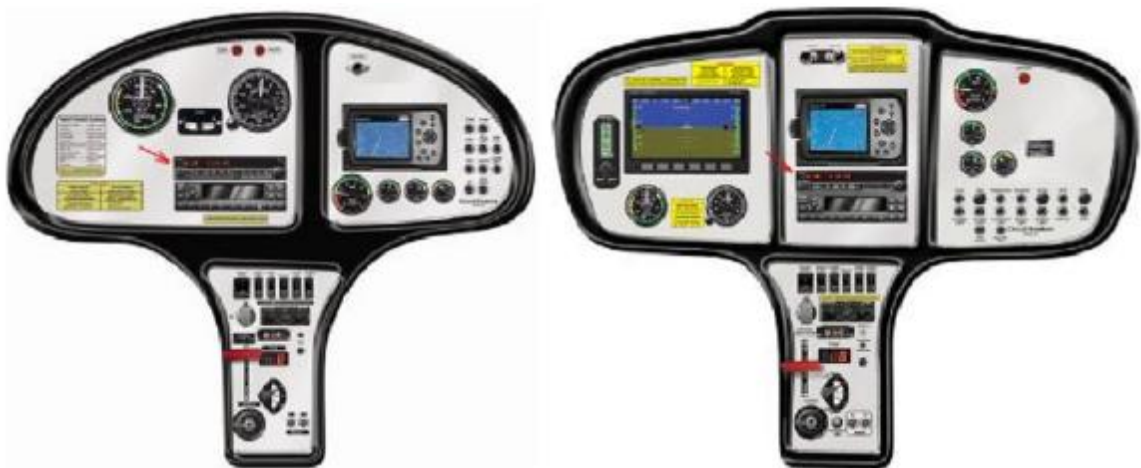
Fig. 1

Typical installation locations of the units are shown in Fig. 1.

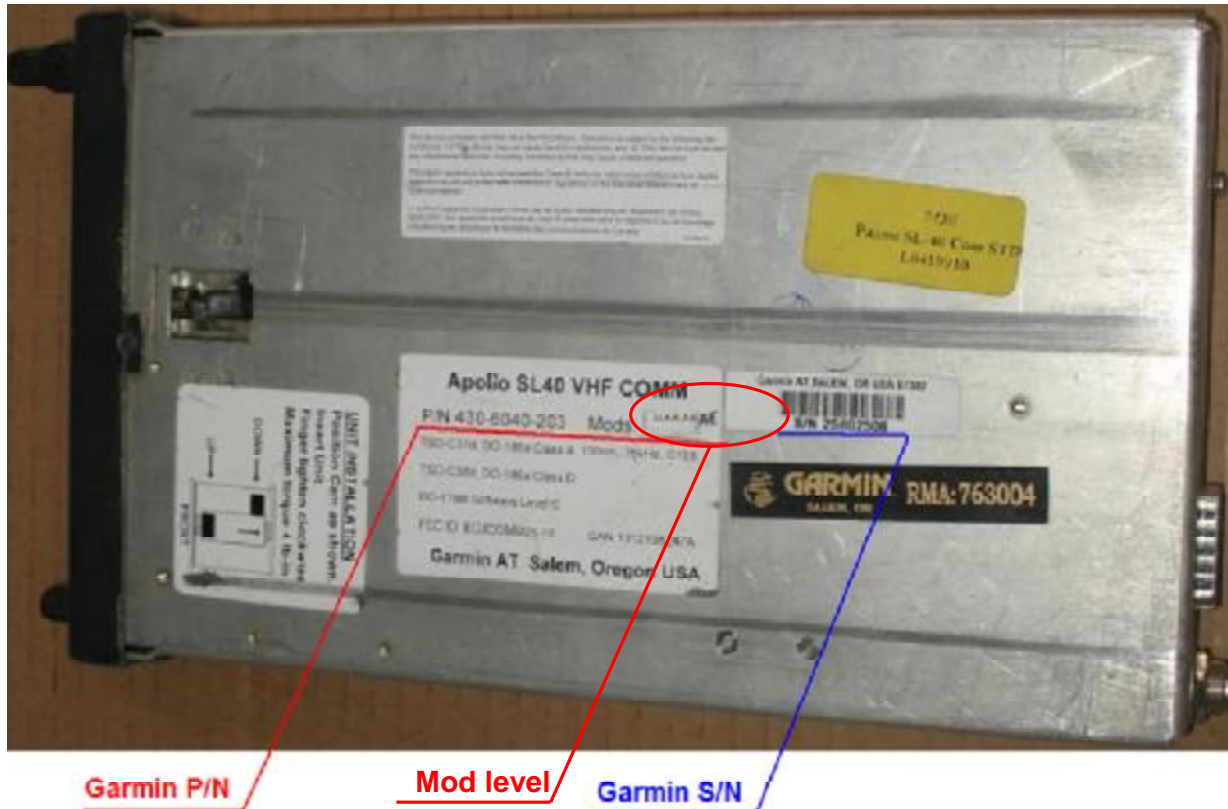
Fig. 3

Identify the Mod level from the nameplate on the bottom side of the unit. P/N, Mod level and S/N of the individual unit are shown in Fig. 3.
