# Service Bulletin

## Inspection of BRS Handle Bracket

**SB-LTUL-CTSW-12**

**SB-LTUL-CTSL-03**

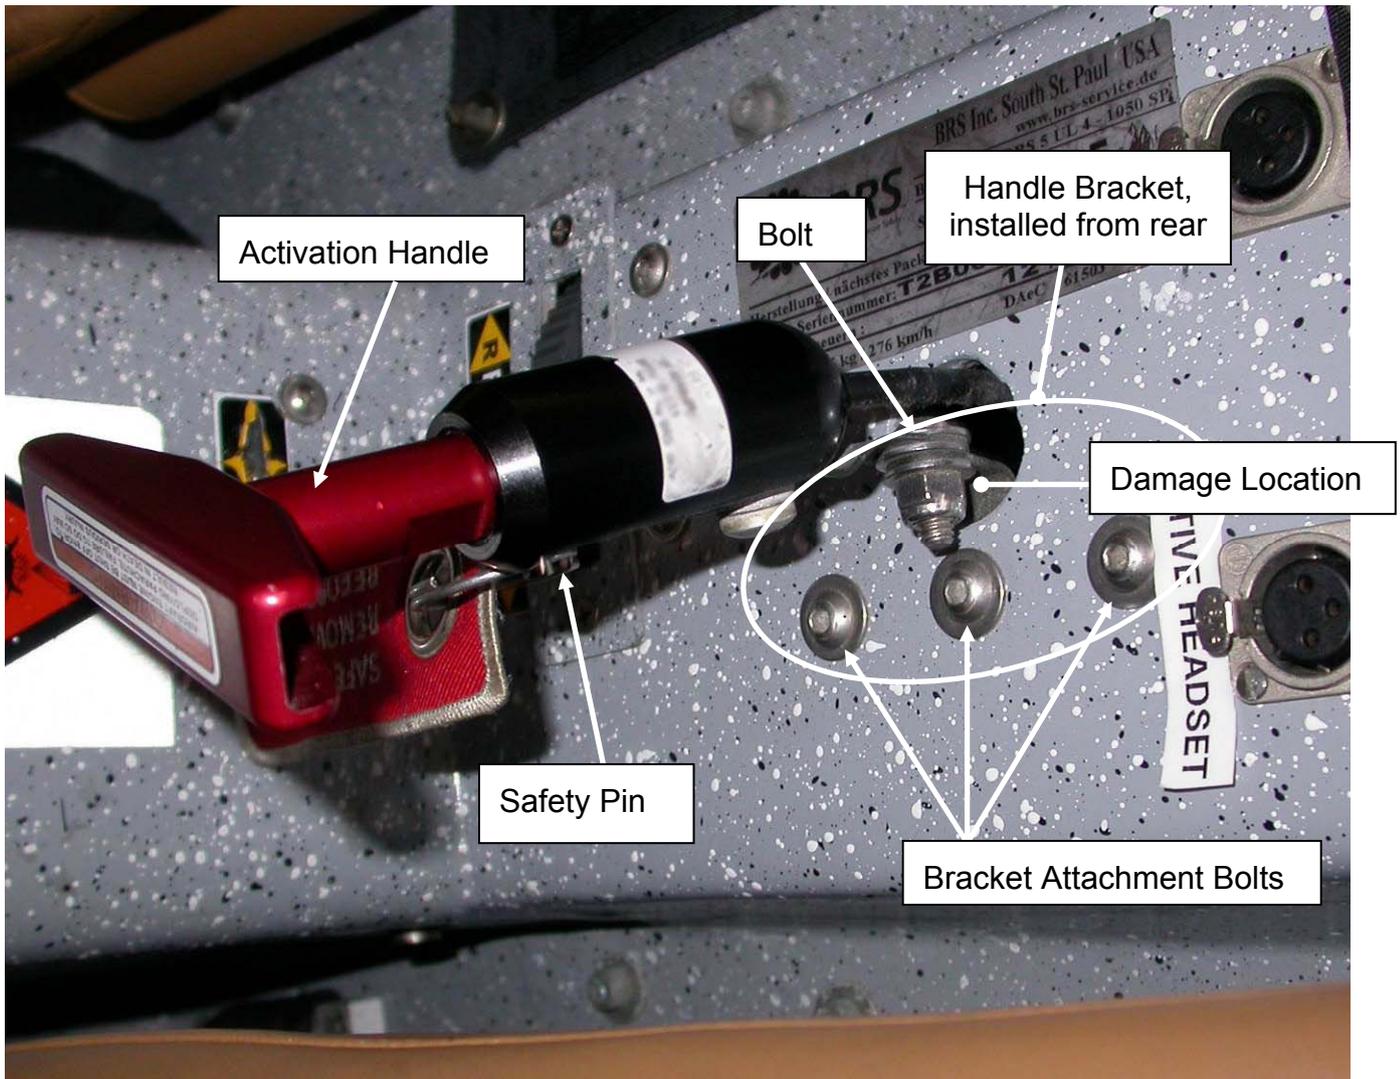
Fig.1 - Handle Installation from Cabin Side.

Inspect the BRS handle bracket for the absence of cracks in the bend radius at the base plate. See Fig. 1 for identification of the bracket.

**▲ Warning:** In case of doubt remove the handle bracket for a better inspection possibility. Fig. 1 above shows the bolts that are required to be removed in order to remove the bracket. For re-installation, use new self-locking nuts and apply tamper proof torque marker.

- Obtain new bracket from either Flight Design or BRS, under reference to this SB.
- Remove the old bracket by removing the bolts identified in Fig. 1.
- Install the new bracket in reverse order. Use new self locking nuts and mark nuts with tamper proof torque marker.
- Take pictures in high resolution of the cracked area on the removed part. The crack might be more visible when you remove the finish with sand paper.
- Permanently destroy the removed bracket, to avoid unintended re-installation. Repeated bending of the cracked area will make it break completely.
- Inform Flight Design using the Service Difficulty Reporting form (SDR). Provide full aircraft details and pictures of the cracked part.

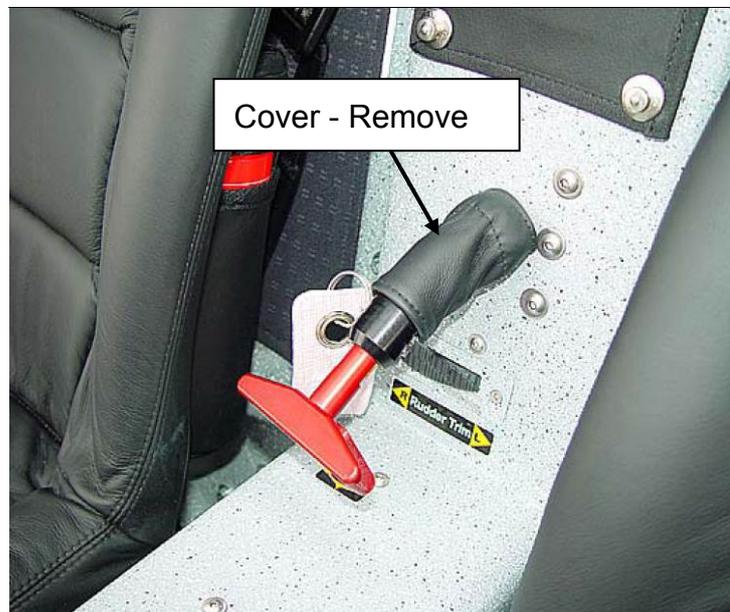
Fig. 2

- ▲ **Warning:** Before conducting the inspection, positively confirm that the safety pin is securely inserted into the activation handle, making it impossible to inadvertently activate the rescue system.
- When the handle bracket is sealed with a fabric or leather cover, then remove this cover before conducting the inspection (Fig. 2).

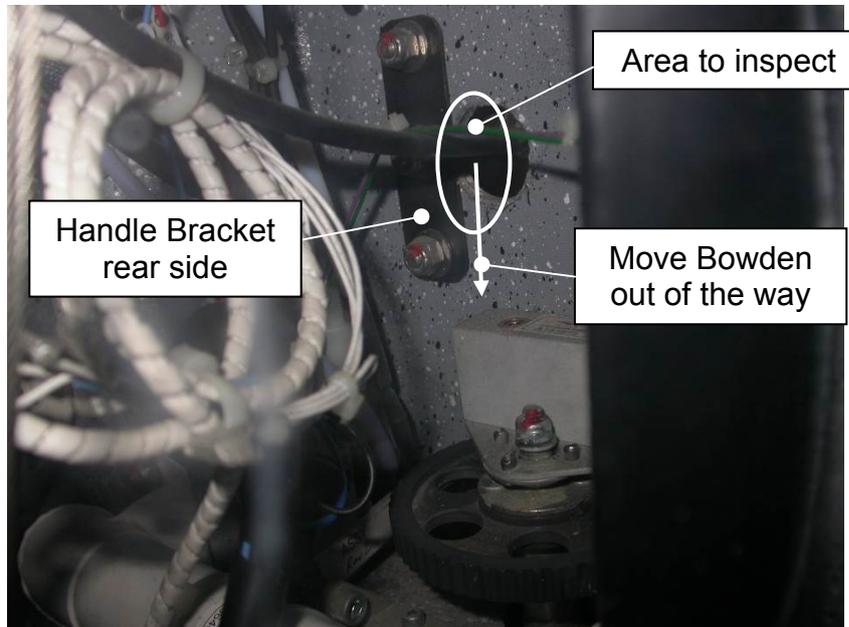
Fig.3- Handle bracket from luggage area side.

- Open on the right side baggage compartment door.
- Ensure accessibility of the bending radius for inspection. Carefully move the Bowden cable up or down, so that you can get unhindered access.
- Use a flashlight and magnifying glass, and inspect for signs of cracking. Typically cracks will start from the edge of the metal lug, and grow across the lug at one position of the bending radius. Most likely you will be best able to detect the crack from the rear side, which is the outside of the bend.
- Fig. 3 shows the where you need to inspect the bracket handle from the rear side.

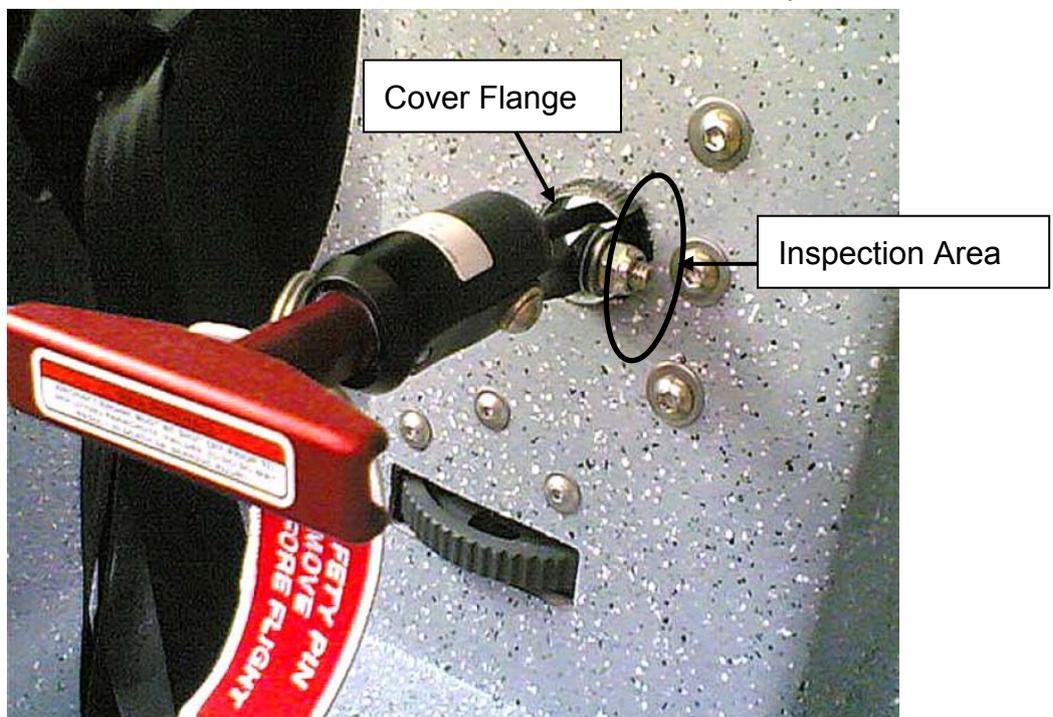
- Continue inspection from cabin side. The cover flange identified in Fig. 4 may hinder good access. In case of doubt, remove the bracket and conduct the inspection disassembled.
