Safety Alert

CTLSi Rotax Redundancy Diagnosis SA-LTUL-CTLS-04

Diagnosis of the Regulator board A and B connection on the engine Rotax 912iS.

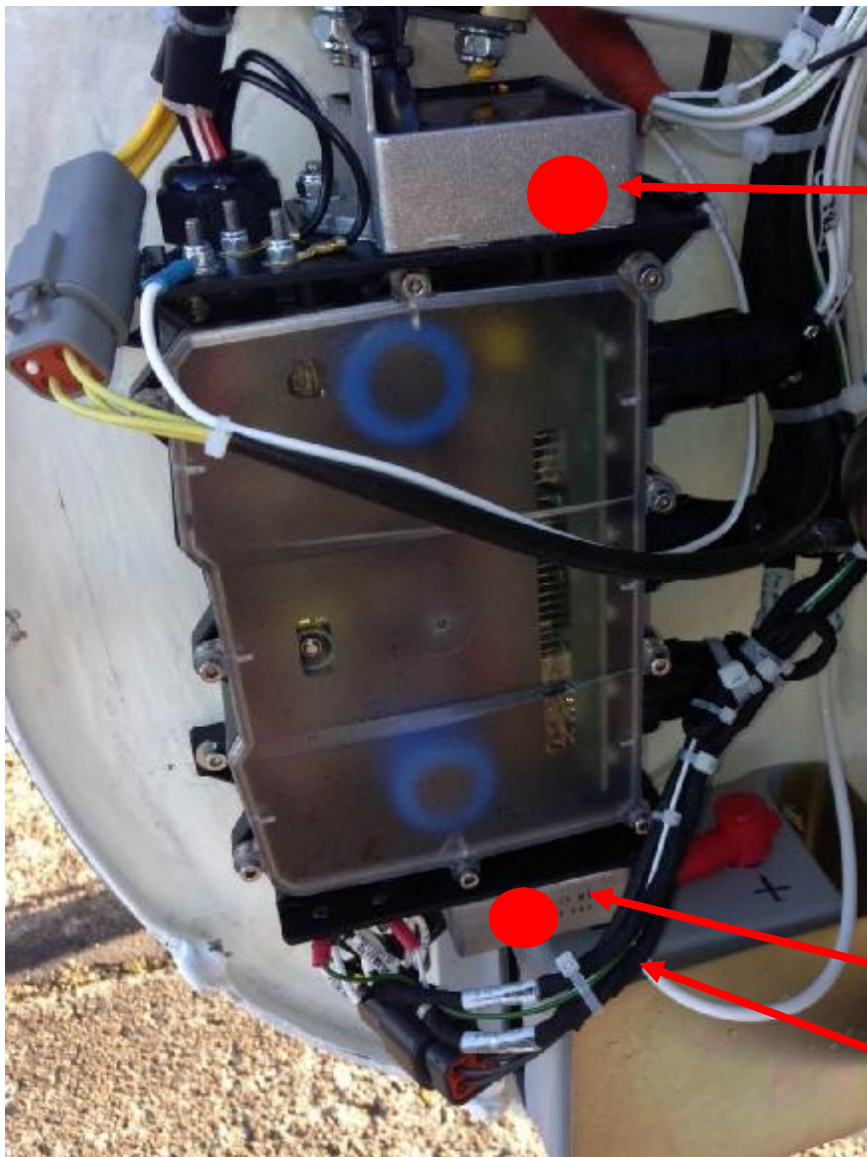
Fig.2

Use a Multimeter to verify electrical ground connection between the regulator Board A and B (red marked points on the Fig.2).

There **must not** be an electrical connection between Regulator Board A electrical ground and Regulator Board B electrical ground.

▲ Warning: Do not operate the aircraft if there is an electrical ground connection between Regulator Board A and B.

If there is ground contact, the reason may be that the Lane A harness ground wires are wrongly connected with Lane B regulator board (upper regulator, above the fuse box). In this case, remove the Lane A wiring harness end (also marked with a label as "Lane A") from the Lane B regulator board. Connect this wiring harness end to the Lane A regulator board, which is the one below the fuse box. Fig. 2 shows the correct step. Re-do the test with the multimeter as above. The aircraft may be operated again, when there is no more ground contact between the two regulator boards. If the problem persists, please contact Flight Design for further instruction.

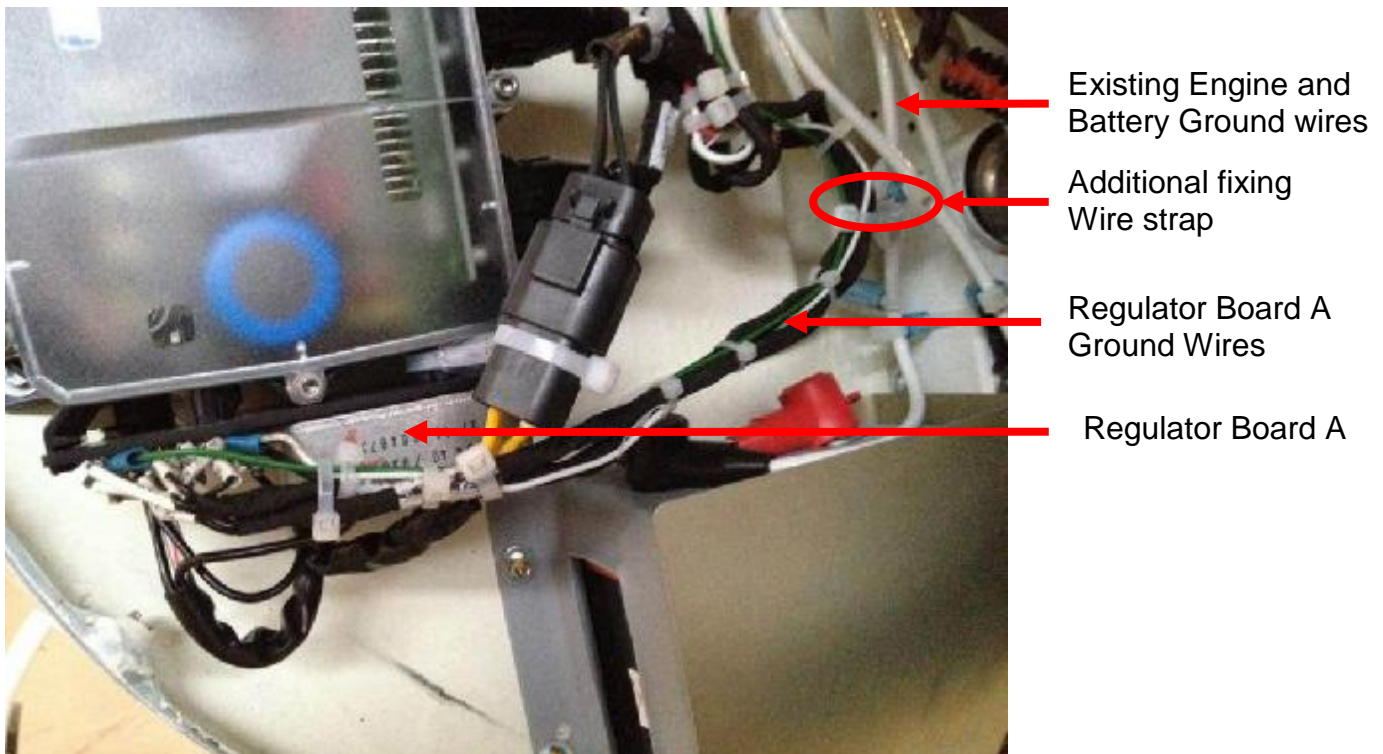
Fig.3

Check Lane A ground wires length: it has to be short enough so that it cannot be connected inadvertently to Regulator Board B during maintenance. If the wires are too long, additionally fix Lane A ground wires to existing engine/battery ground wires using wire strap following Fig.3.

To avoid the possibility for a re-occurrence of this mistake, add an additional harness fixation to the questionable harness end that makes connection to the wrong board physically impossible.

Check that all wires are secured properly and protected from unintentional damages. Cut extra length of wire strap. Make sure it is removed from the engine compartment.
