SAFETY ALERT

Servo Tab Spring

SA-LTUL-CTSW-02

Technical Advice No. 12e
 November 1st, 2006

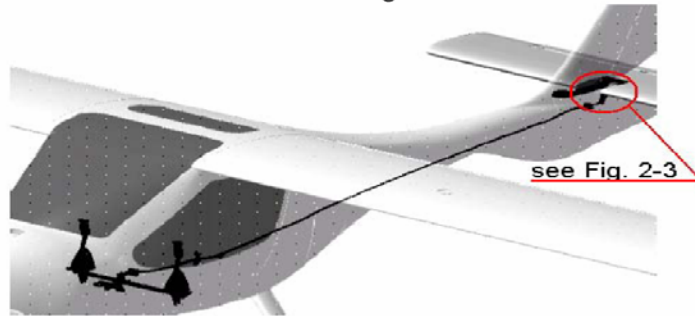
Fig. 1

It was found that the anti-servo tab spring could, *under extreme conditions*, cause a sudden change in trim force pressure. This could result in a sudden pitching down movement of the aircraft that is most pronounced as Vne is reached or exceeded.

Action:
 Flight Design is mandating a modification of the trim system on the affected aircraft that consists of replacing the original spring and associated spacer and washer with a new spring and telescopic spring guide assembly (Fig. 1)

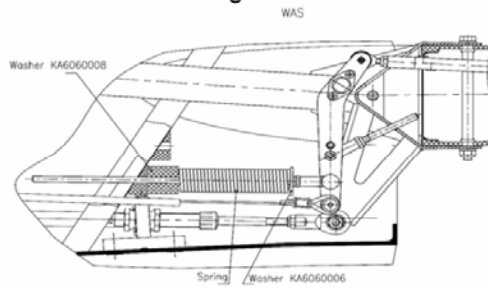
Fig. 2 (Old)

- Important:
- A. The new spring is longer than the original (37 (Fig 3) windings instead of 35 windings). The original one is too short and must not be used.(Fig 2)
 - B. The movement of the original, shorter spring is limited at one end by a plastic spacer (KA6060008) and at the other end by a washer (KA6060006) (Fig 2). These parts are also not reused.
 - C. When mounting, the gliding surfaces of the telescope and the surfaces contacting with the spring have to be lubricated by use of Aeroshell Grease 6 or equivalent, to support frictionless operation.
1. Mount the stabilizer in accordance with the Maintenance Manual and check for correct operation.
 2. Tag the original spring with the aircraft serial number and return to Flight Design.
