# SAFETY ALERT

## Servo Tab Spring

### SA-SECS-CTSW-02

Technical Advice No. 12e  
 November 1<sup>st</sup>, 2006

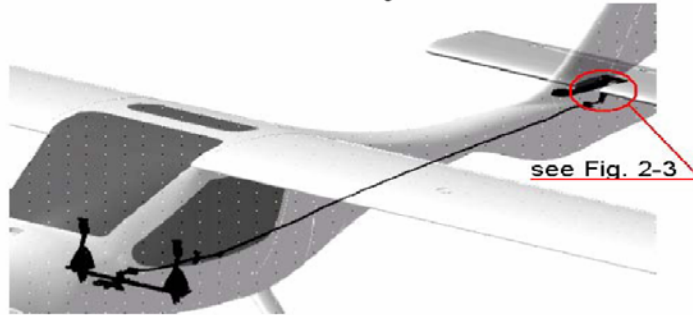
Fig. 1

It was found that the anti-servo tab spring could, *under extreme conditions*, cause a sudden change in trim force pressure. This could result in a sudden pitching down movement of the aircraft that is most pronounced as Vne is reached or exceeded.

Action:  
 Flight Design is mandating a modification of the trim system on the affected aircraft that consists of replacing the original spring and associated spacer and washer with a new spring and telescopic spring guide assembly (Fig. 1)

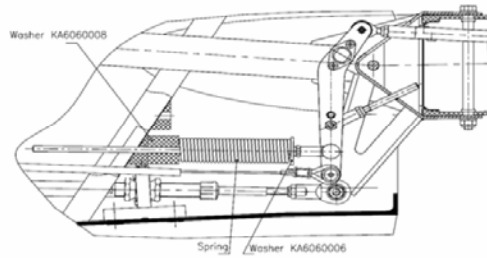
Fig. 2 (Old)

- Important:
- A. The new spring is longer than the original (37 (Fig 3) windings instead of 35 windings). The original one is too short and must not be used.(Fig 2)
  - B. The movement of the original, shorter spring is limited at one end by a plastic spacer (KA6060008) and at the other end by a washer (KA6060006) (Fig 2). These parts are also not reused.
  - C. When mounting, the gliding surfaces of the telescope and the surfaces contacting with the spring have to be lubricated by use of Aeroshell Grease 6 or equivalent, to support frictionless operation.
1. Mount the stabilizer in accordance with the Maintenance Manual and check for correct operation.
  2. Tag the original spring with the aircraft serial number and return to Flight Design.
