SERVICE BULLETIN

Landing Gear Inspection

SB-ASTM-CT__-01;
SB-ASTM-CT2k-02;
SB-ASTM-CTSW-02

FLIGHT DESIGN USA SAFETY DIRECTIVE No.10

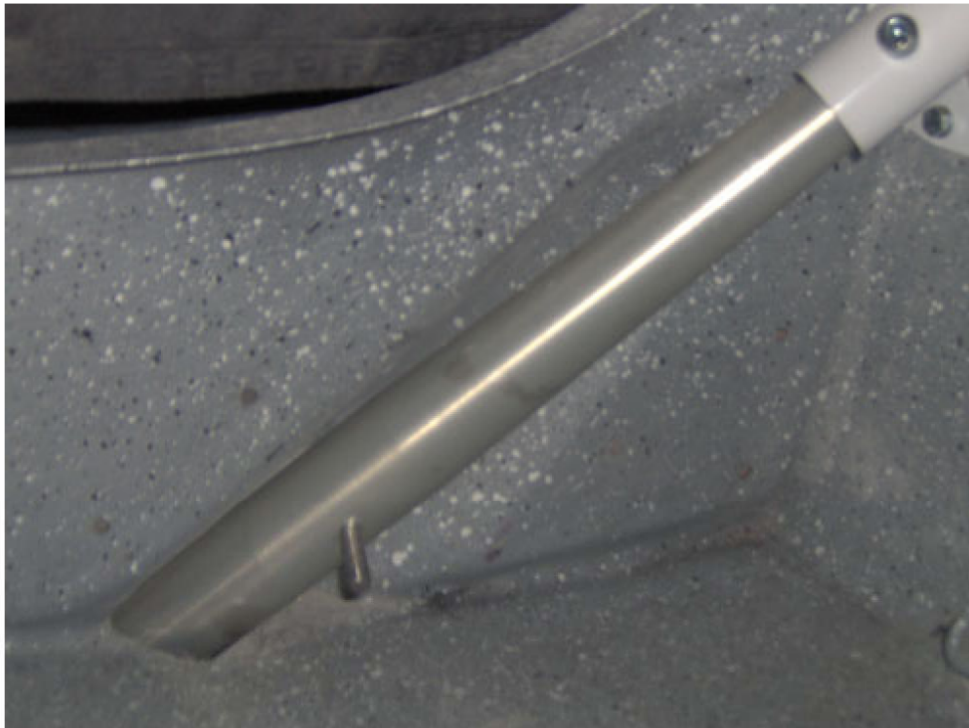
There has been a reported fatigue crack and subsequent failure of a previously damaged Main Landing Spring Bar (part no. 4020001). The aircraft involved was used for training and had more than 450 hours in service.

The failure occurred at the Main Gear lower attach point, behind the Rear Reinforcement (part no. KA1000410L(R)).

1. Unscrew the central locknut and remove the Main Gear Reinforcement (part no. KA1000410L(R)).
2. Apply dye penetrant or use a magnifier and observe for any cracks with the aid a small inspection mirror.
3. Replace the Main Gear Reinforcement; replace the central locknut.
