Service Notification	
	Flight Design GmbH Sielminger Str. 51 D-70771 L.-Echterdingen Tel.: +49(0)7021 80460-0 Fax: +49(0)7021 80460-69 E-Mail: airworthiness@flightdesign.com	SN-LTUL-CTLS-02 Revision 00
	Date of Initial Publication: 28-Mar-2011 Publication Date of this Revision: 28-Mar-2011

Service Notification

Elimination of Noise in Radio from Dynon SkyView SV-D1000 SN-LTUL-CTLS-02

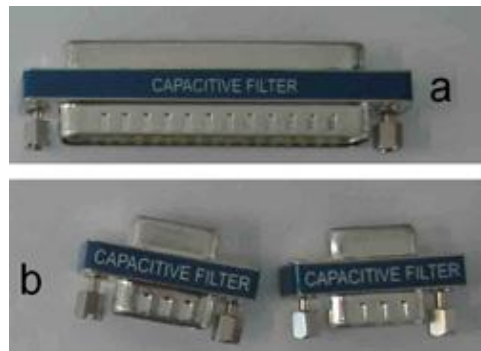
Fig. 1

- One capacitive filter for D37 port (Fig. 1, item a);
- Two capacitive filters for D9 ports (Fig. 1, item b).

Two installation kits of capacitive filter for Dynon SkyView display:

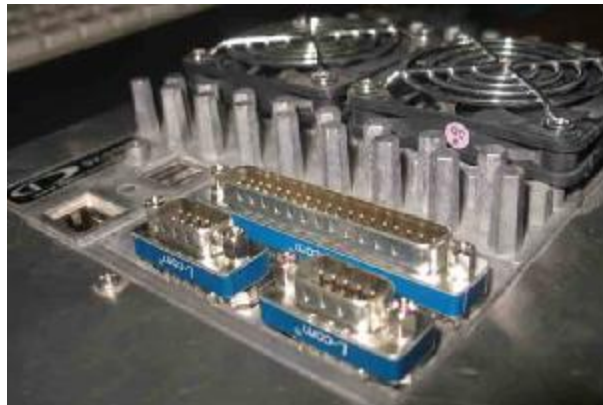
Fig. 5

Dynon SkyView SV-D1000 display, when is turned on, may cause noise in the transceiver and intercom.

3. Install the capacitive filters: One capacitive filter D37 and two capacitive filters D9 on the left SkyView SV-D1000 display by screwing of the capacitive filters' mounting screws into the SkyView SV-D1000 display's plugs (Fig. 5).
