Service NOTIFICATION

Upper rudder hinge

SN-LTUL-CT__-04; SN-LTUL-CT2k-05; SN-LTUL-CTSW-03

TECHNICAL ADVISE No. 5

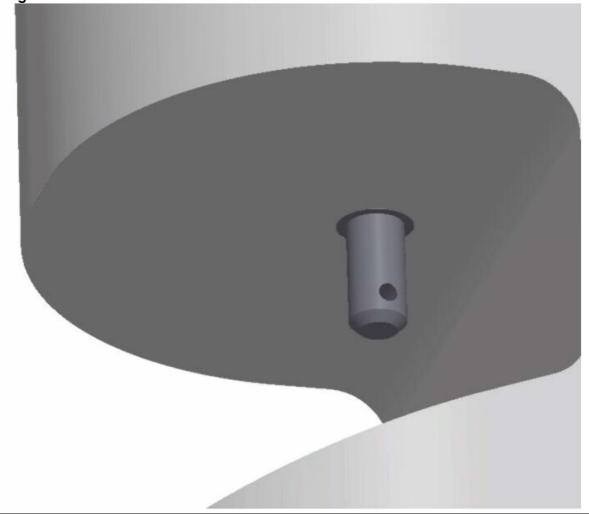
Fig. 1

- 1. Check that the bush is fixed, but not loosened.
- 2. Check that the position of the bush and the rib is correct (refer to Fig.1). The position of the bush on Fig. 2 & 3 is not correct and shown in purpose.
- 3. If items 2& 3 are found let repair rudder at an authorized repair station.

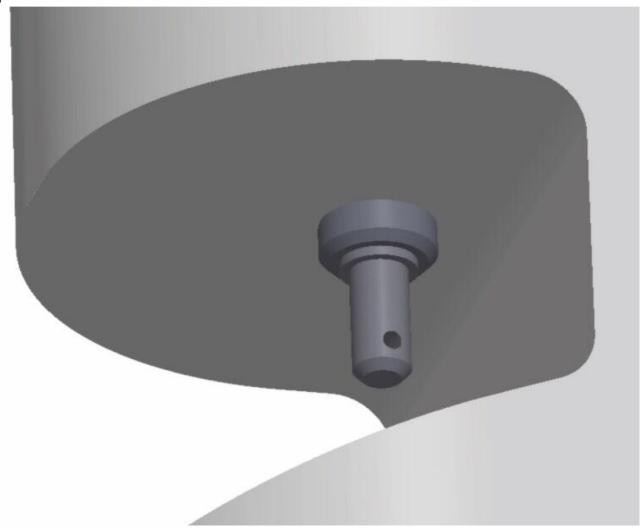
Fig. 2

At the plane serial no. 01-06-02-12 the bush, part no. KA3020511, got loose at the rudder nose rib, part no. KA3020500ASSY at 80 hours.

It's very unlikely but as it seems gluing between the threaded bush and the rib was destroyed and the bush was screwed into the rib.
