FLIGHT DESIGN	Service Letter
Flight Design general aviation GmbH	SL-ASTM-CTLS-02
Am Flugplatz 3, D-99820 Hörselberg Hainich, Airfield Eisenach-Kindel Web: www.flightdesign.com ; Phone: +49 36920 7530-10 E-mail: airworthiness@flightdesign.com	SL-LTUL-CTLS-02
	SL-LTUL-CTSL-01
	Revision 00
	Date of Initial Publication: 24-Sep-2020
	Publication Date of this Revision: 24-Sep-2020

Drain Holes in Air Filter Box SL-ASTM-CTLS-02 SL-LTUL-CTLS-02 SL-LTUL-CTSL-01

Model: CTLSi-LSA, CTLSi, CTSLi

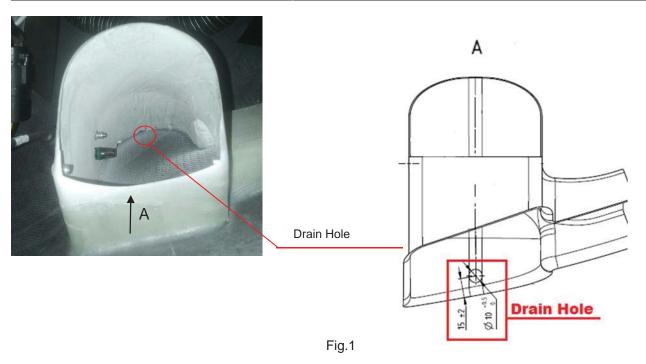
Type design includes a drain hole in the air filter box. As a result of a quality escape, in aircraft was delivered without such a drain hole. When flying through heavy rain, water can be trapped in the air filter box and the air filter can be moistened to a level that causes rough engine running in case of a missing drain hole.

Detach the air filter together with cover from the filter box. Check the filter box to make sure the drain hole is observed.

In case when the drain hole is missing, is necessary to drill drain hole as shown below, see Fig.1, view A.
