Service Bulletin

Inspection of Float Mount Brackets

SB-ASTM-CTLS-18

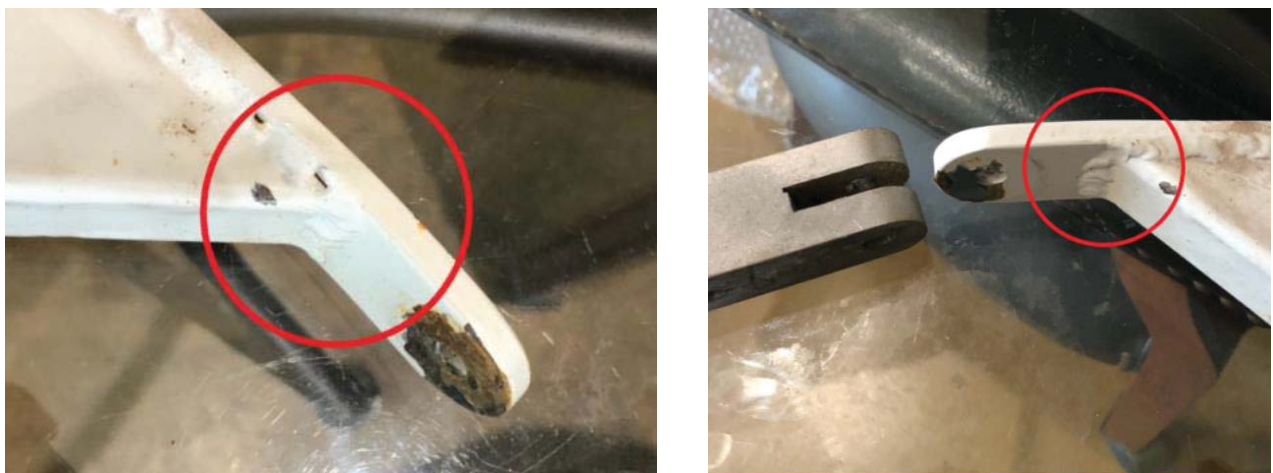
FIG 2

An incident occurred on a Clamar/Airtime Float equipped CTLS where the forward upper float attachment bracket failed on a semi rough water landing. The aircraft had been flying for 9 years and had an unknown amount of water landings and service history.

Carefully lift the forward fuselage and disconnect the forward struts from the tangs at the end of the square tubular cross member. Inspect the welds and steel tang section of the cross member circled in Fig 2 for cracks, unusual bends or corrosion.
