<b>Safety Alert</b>	
	<b>Flight Design GmbH</b> Sielminger Str. 51 D-70771 L.-Echterdingen Tel.: +49(0)7021 80460-0 Fax: +49(0)7021 80460-69 E-Mail: <a href="mailto:airworthiness@flightdesign.com">airworthiness@flightdesign.com</a>	<b>SA-LTUL-CTSW-06</b> <b>Revision 00</b>
	Date of Initial Publication: <b>16-May-2012</b> Publication Date of this Revision: <b>16-May-2012</b>

# SAFETY ALERT

## Trim Tab Retrofit CTSW SA-LTUL-CTSW-06

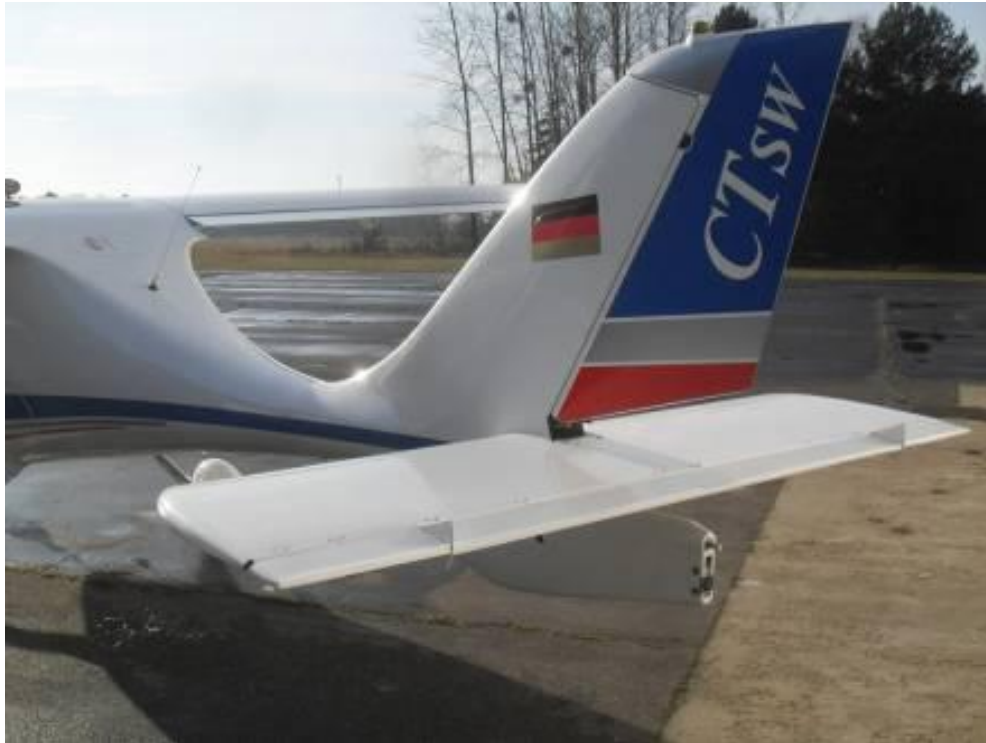
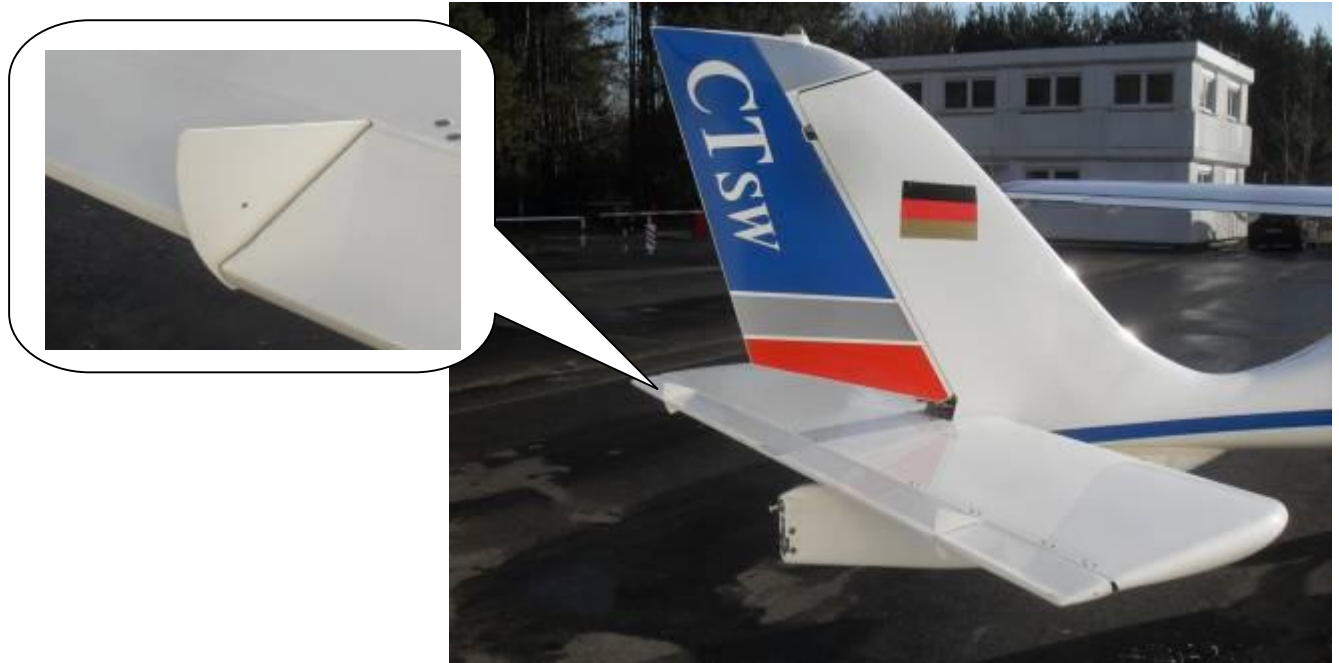
Retrofit of the CTSW full-span Trim Tab to the short Trim Tab (See Fig. 1 of an aircraft after retrofit). This retrofit must be completed within the timeframe identified in Chapter 1.5 of this SA.
