Service Bulletin

Dynon Autopilot Servo SV42T Inspection and Replacement of Linear Actuator Servo Pulley

SB-ASTM-CTLS-15**SB-ASTM-CTSW-14**

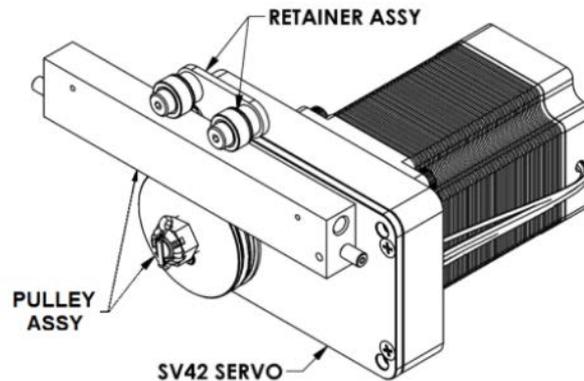
Fig. 1

Some of CT aircraft equipped with Dynon SkyView autopilot system can be affected by Dynon Service Bulletin [1] mentioned in chapter 1.2. Possible cracks in pulley of the SV42T linear actuator servo is the reason for the Dynon Service Bulletin. This may cause a poor autopilot system performance and include a risk of interference with flight controls.

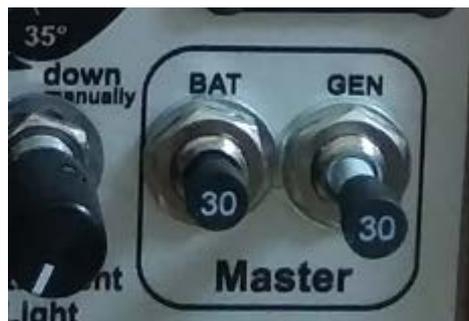
Fig.1

Before starting, set the parking brake. In addition always place chocks to the wheels to avoid rolling of the aircraft in case the brake gets loose or the brake lines are opened. Be sure that all equipment and instrumentation is working correct prior to conduct of this instruction. Turn off the electricity of the plane by pulling out the master switch BAT and GEN (Fig. 1).

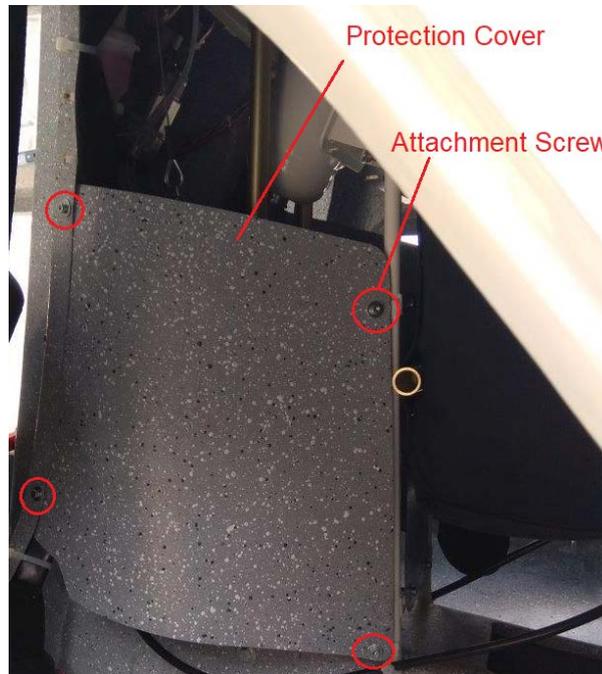
Fig. 2a. Removals of protection cover on CTSW planes

- Open left luggage door;
- Remove protection cover of control system by unscrewing attachment screws M4, marked by red circles on Fig. 2a or Fig. 2b (which applicable).

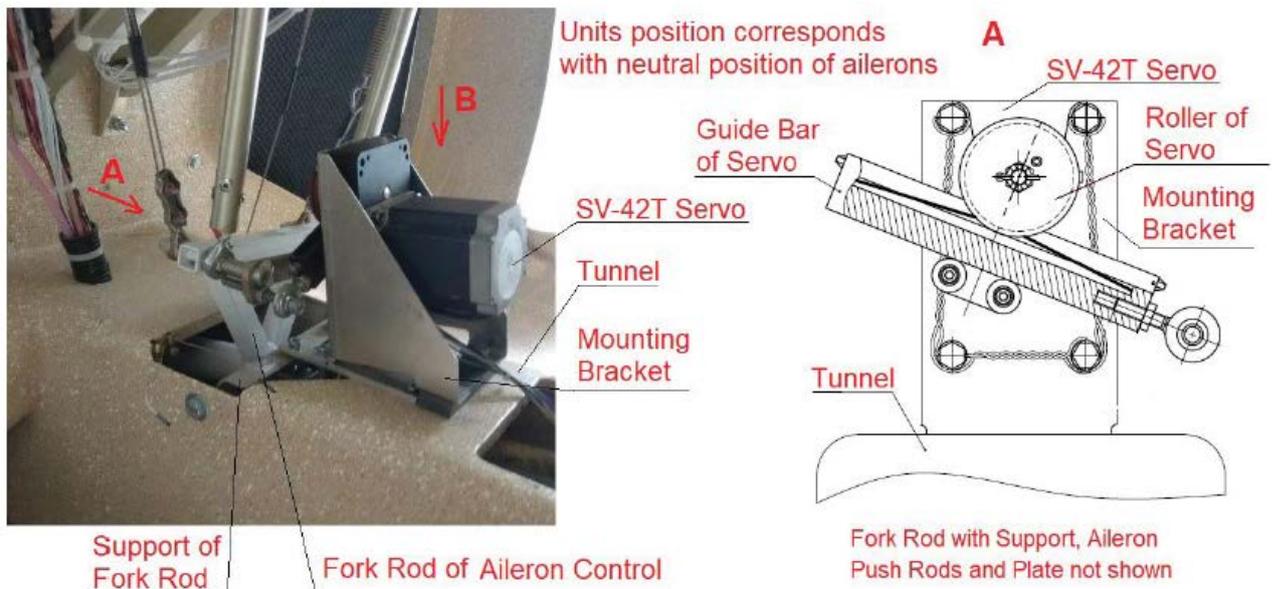
Fig. 3. Installation of Roll Servo SV42T to CTLS

Installations of autopilot roll servo SV42T to CTLS and to CTSW planes is very similar with some small differences. With this the servo pulley removal procedure provided below is applicable for both airplane types.

- **Note:** Guide bar has thread bores for rod end on both ends. Verify the correct position of guide bar relatively to the pulley. The correct position for CTLS installation is shown on Fig. 3 (guide bar under the pulley). The correct position for CTSL installation is shown on Fig. 4b (guide bar above the pulley).

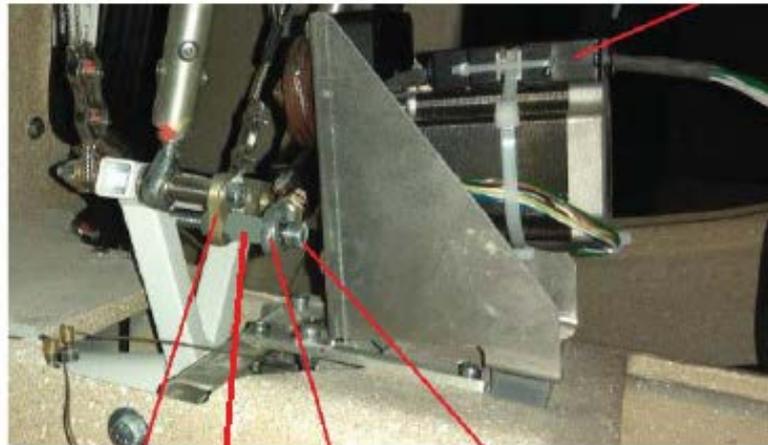
Fig. 4a. Mechanical connection of servo to aileron control (CTLS)

1. Detach servo guide bar with rod end from an aileron control system by unscrewing of the bolt-nut connection (Fig. 4a and Fig. 4b)

- **Note:** Before unscrewing the bolt-nut connection, note and put down amount of washers and bushes in a Spacer Set (as shown on Fig. 5a and Fig. 5b) between the aileron control system components and the rod end of servo guide bar. During the final assembly of system the same Spacer Set should be installed back.

Plate Rod End Bolt-nut Connection
Spacer Set

3. Connect the rod end to the control system by the bolt-nut connection with spacer set. To be done in back order of item 2 of subchapter 3.3.4. Use the new self-locking nut p/n C9996334. Tight the bolt-nut connection with torque 9 Nm.

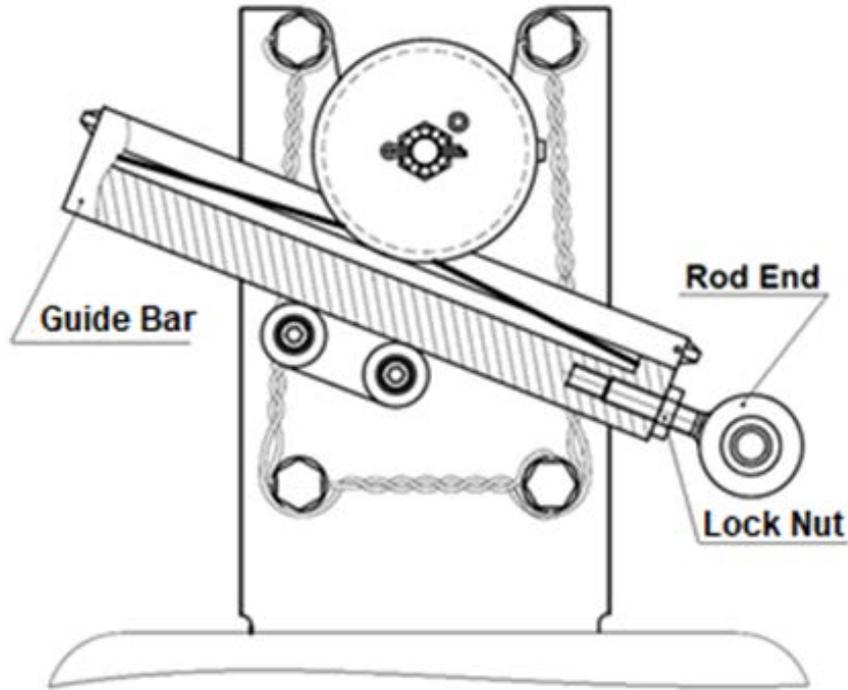
Fig. 5

2. Unloose Lock Nut of the servo Rod End (Fig. 5) by turning of nut counterclockwise approx. for 15°-30° (it should be enough to screw-out rod end from guide bar later). Keep Lock Nut in such position on the Rod End. Do not screw out Nut more so as will help install Rod End properly at unit assembling. Then screw-out the Rod End from the servo guide bar together with Lock Nut.

5. After check and adjustment (if required) tighten a lock nut of the Rod End.

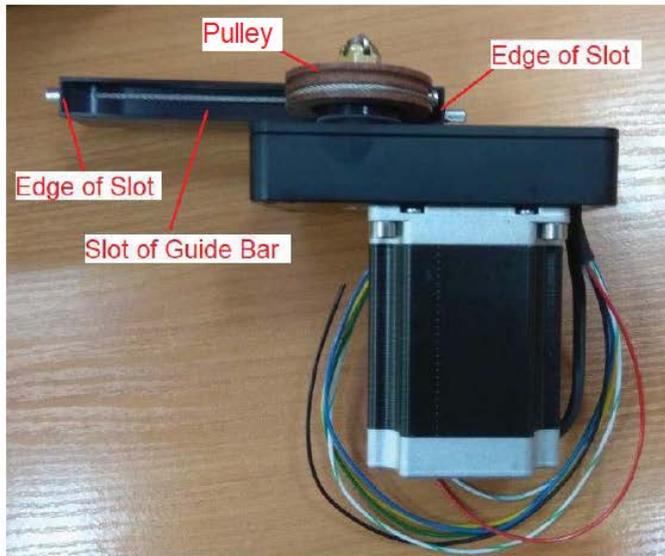
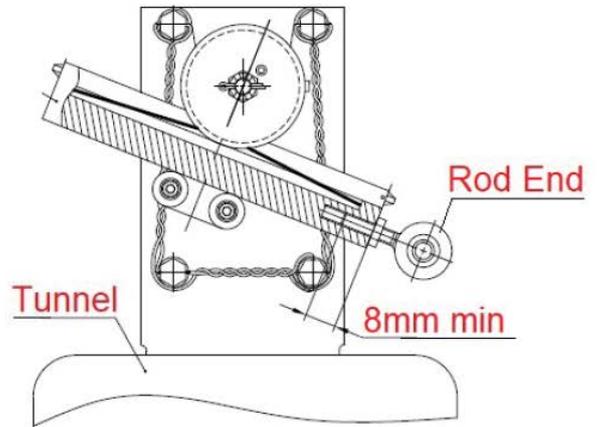
Fig. 6

4. Verify that within the full range of aileron control system deflections (right-left) the pulley does not touch the end of the guide bar slot, see Fig. 6. If the pulley touches the end of the guide bar slot, adjust the rod end of the guide bar. Verify that the rod end thread is screwed in to the guide bar is not less than 8mm.

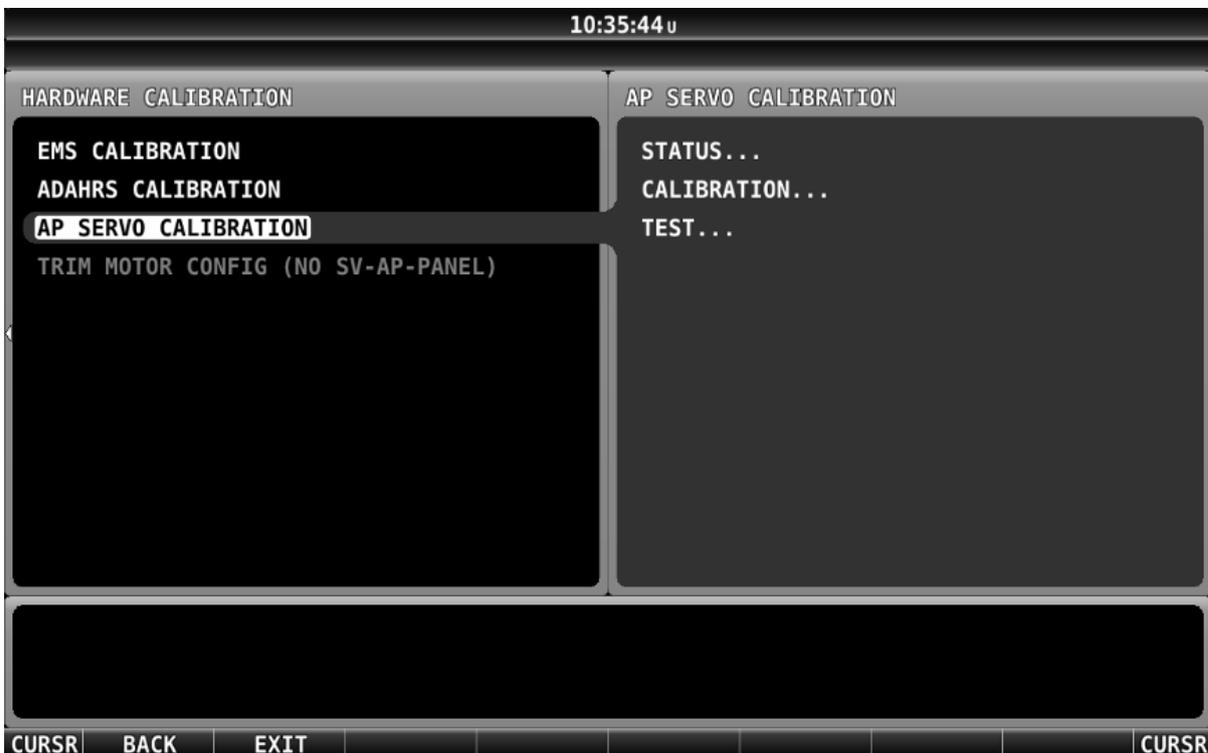
6. Perform servo calibration from Dynon Skyview:

- Switch on the power and all avionic equipment together with autopilot circuit breaker;
- Enter to the SYSTEM SETUP menu on any SkyView display;
- Enter to submenu HARDWARE CALIBRATION > AP SERVO CALIBRATION > CALIBRATION. Then follow instructions on the screen.

- When the calibration and test is completed successfully, EXIT from the SETUP MENU.
- After completion of calibration switch off all avionics and master circuit breakers BAT and GEN.
