## **Service Bulletin**

SB-ASTM-F2-01, Revision 00

# Introducing Door Latch Reminder Placard SB-ASTM-F2-01

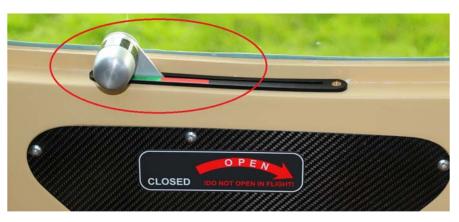
Pic.1 (LATCHED POSITION)

This document introduces a new placard installed on the inner door handle, clearly indicating the securely latched position (refer to pic.1).

To prevent the possibility of doors opening in flight because of improper latching, which pose significant risks to both pilot and passenger, an additional placard on the inner door handle indicating the safely latched position is introduced.
