# SERVICE BULLETIN

## Radiator Isolator Mounts

**SB-ASTM-CT2k-01;**

**SB-ASTM-CTSW-01**

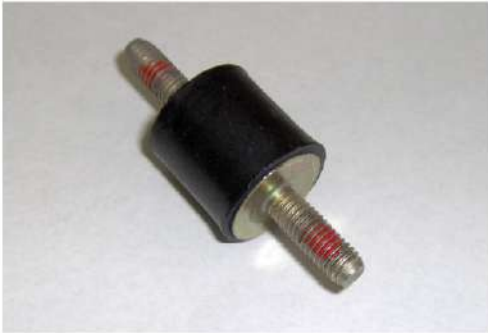
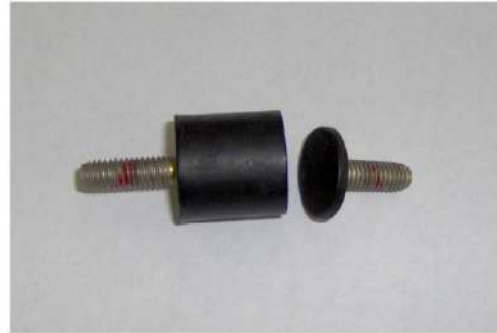
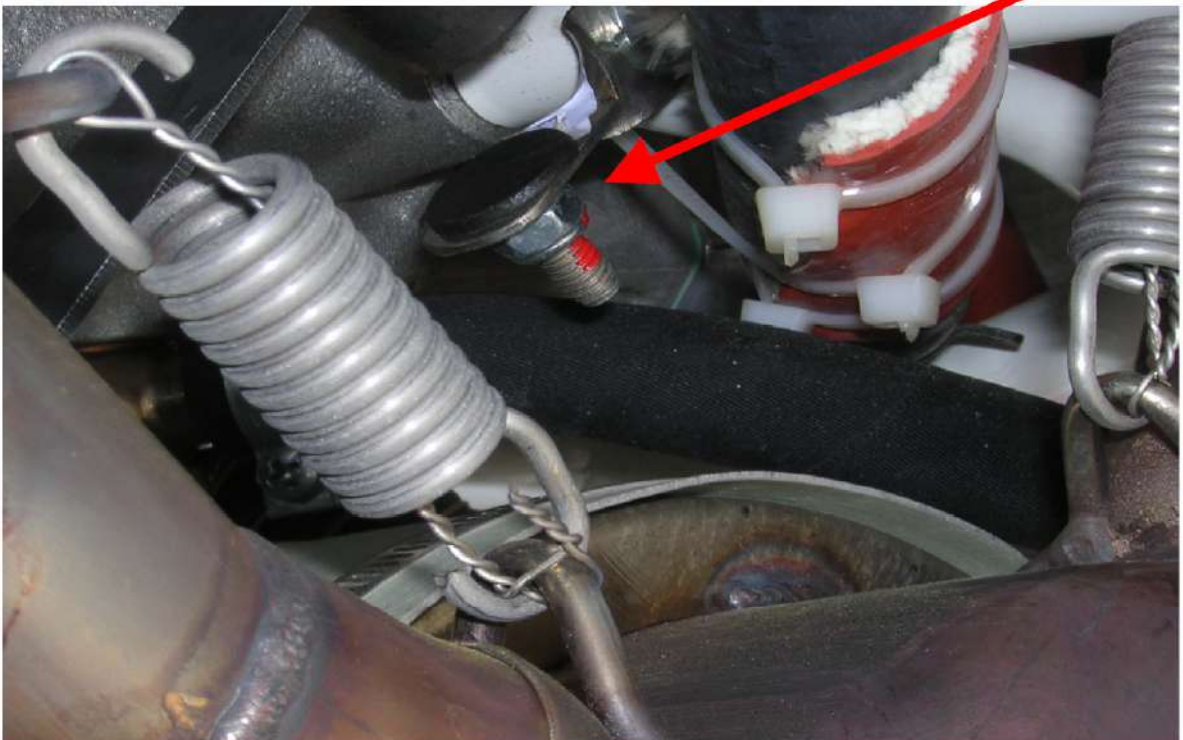
### Information

During a routine inspection of a CT, it was found that the rubber radiator isolator mounts had separated into two parts. Upon examination, three other aircraft were found to have damaged isolators.

Before the next flight, remove the upper and lower cowling. Carefully inspect all radiator isolator mounts by hand. If any are found to be damaged, please contact Flight Design USA to obtain a replacement.

Inspect the radiator isolators at each scheduled inspection interval.
