Service NOTIFICATION

Upper rudder hinge

SN-SECS-CT__-04;
SN-SECS-CT2k-05;
SN-SECS-CTSW-03

TECHNICAL ADVISE No. 5

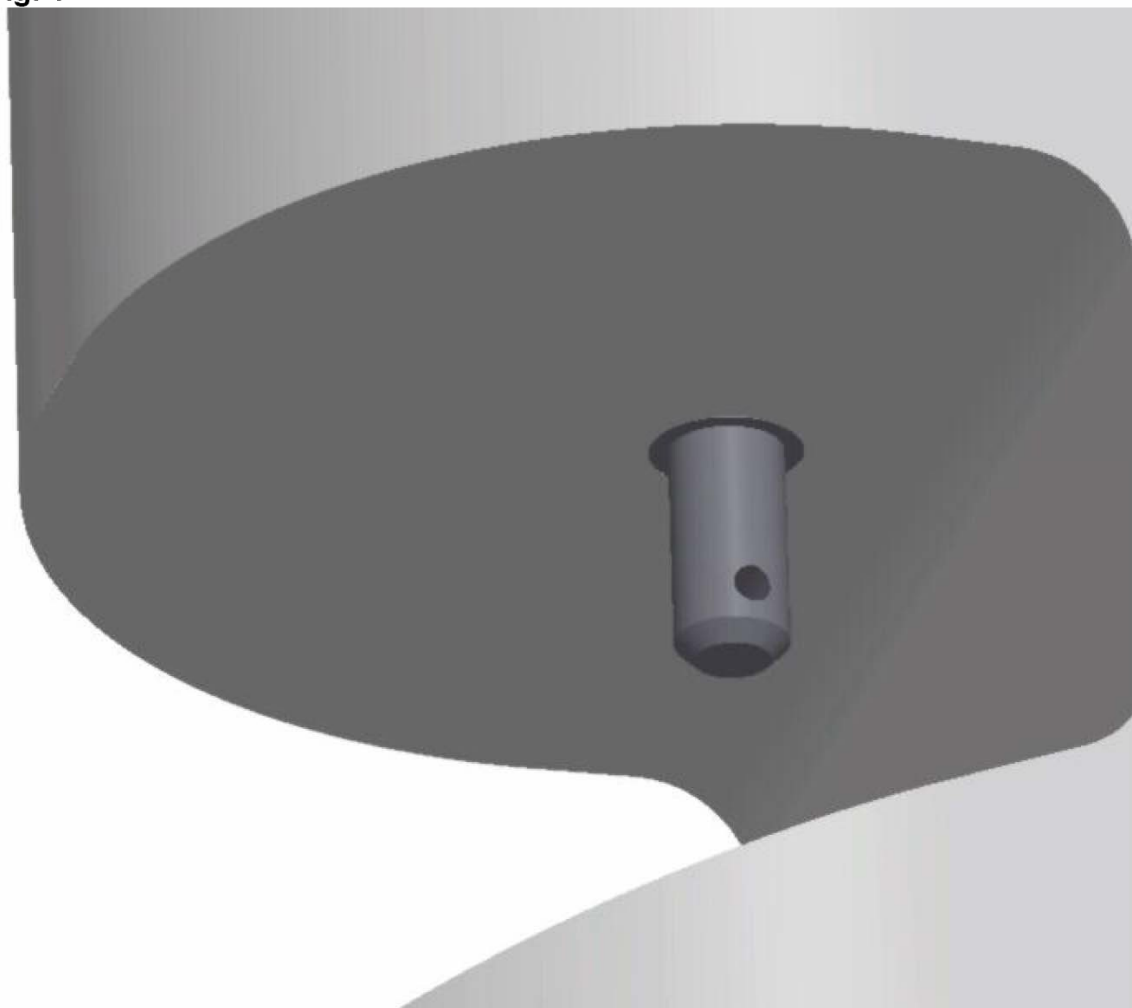
Fig. 1

1. Check that the bush is fixed, but not loosened.
2. Check that the position of the bush and the rib is correct (refer to Fig.1). The position of the bush on Fig. 2 & 3 is not correct and shown in purpose.
3. If items 2& 3 are found let repair rudder at an authorized repair station.

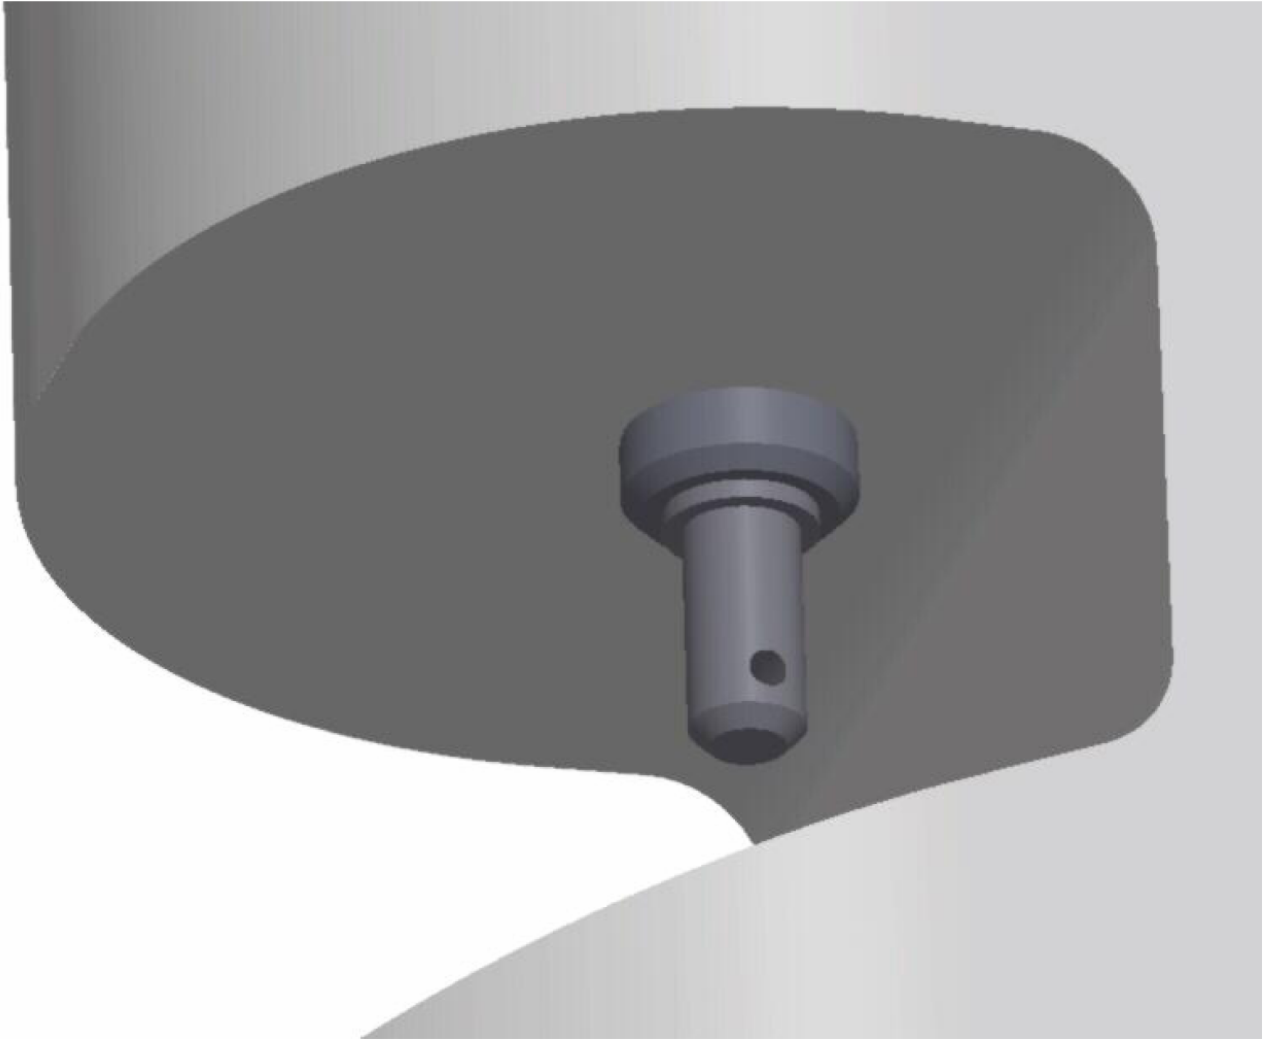
Fig. 2

At the plane serial no. 01-06-02-12 the bush, part no. KA3020511, got loose at the rudder nose rib, part no. KA3020500ASSY at 80 hours.

It's very unlikely but as it seems gluing between the threaded bush and the rib was destroyed and the bush was screwed into the rib.
